Architectural and structural analysis of historical structures

Professional paper

One of the most notable examples of Amasya's cultural heritage is Gok Madrasah (literally: Sky or Blue Madrasah). Gok Madrasah was built in a central location in Amasya. Because of blue glazed bricks used in the structure, the structure has been named Gok Madrasah (Sky or Blue Madrasah) (Figures 1 and 2). Since there is no inscription, the precise construction date is unknown. However, according to its patrons, the madrasah was constructed by Seyfeddin Torumtay, who was a governor in Amasya during the Seljuk period.

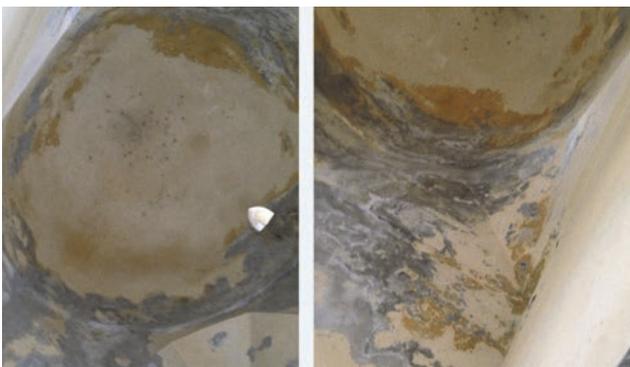
Figure 5. Flaking of plaster

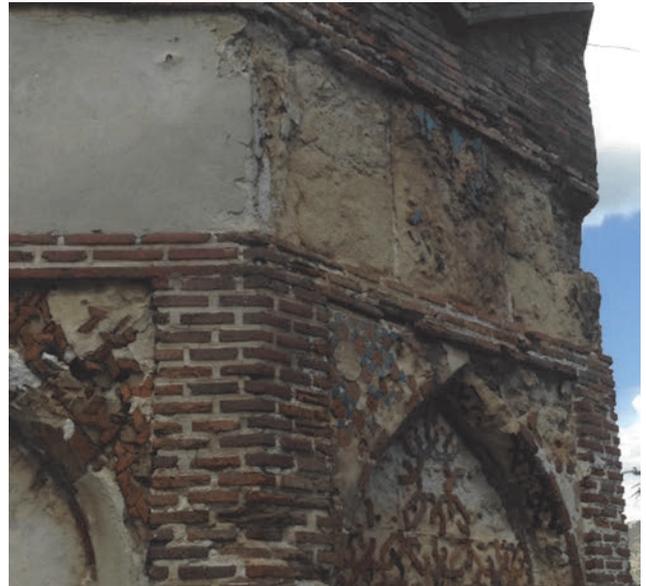
Structural materials have decayed and environmental factors have caused the construction materials to deteriorate (Figure 6). The structure's main problems are the damage to structural elements, loss of material, and decrease in structural strength. The mortar between the stone units on the main façade of the structure has partially eroded (Figure 7) and many irregular micro-cracks were observed on the stones.

Figure 6. Material deterioration on the structure

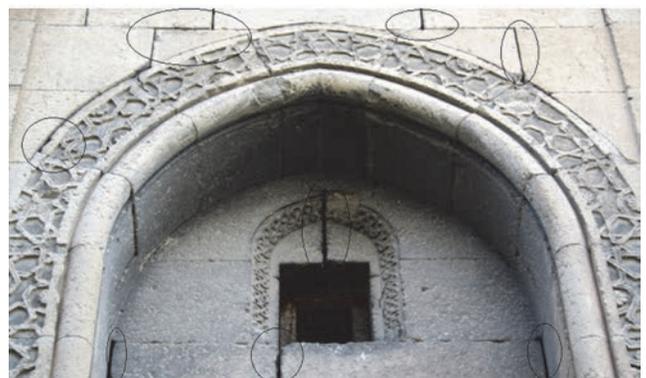
Figure 7. Local mortar damage (mortar between the stone units)

The binding material between the masonry units was partially eroded. The most deteriorated parts of the madrasah are on the octagonal pyramidal section. In some cases, the abrasion and degradations are noticeable on the stone units of the masonry facades. In addition, the madrasah has been subjected to natural disasters and destruction by human hands (Figure 8). Some of this damage is very dangerous because it may cause fatal and destructive cracking and fracturing. In addition, it can cause differential movement of the madrasah components. Consequently, such damage should be taken seriously and precautions should be taken to avoid or to abate its effects.

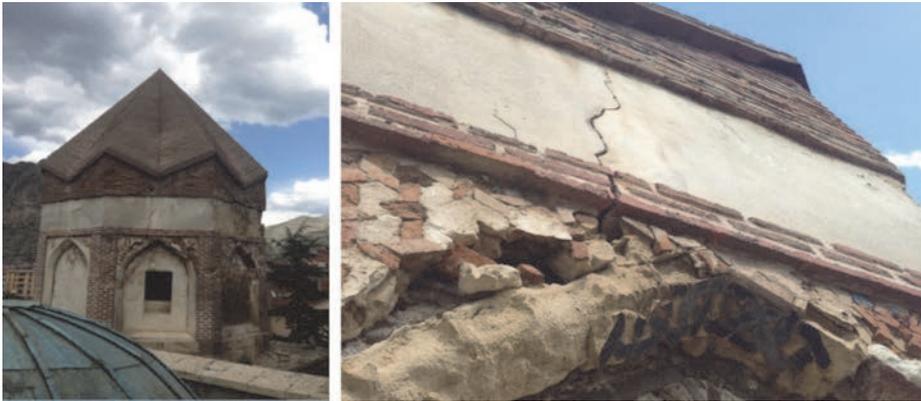
Figure 8. Deep cracks on octagonal pyramidal section

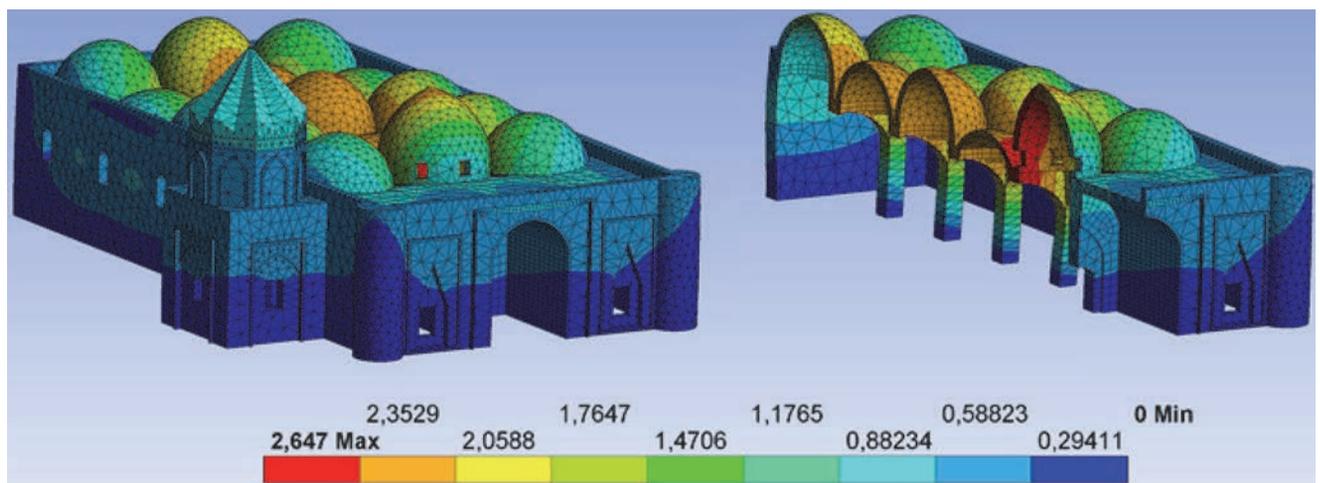
According to static analysis, maximum displacements occurred on top of the middlemost dome and were found to be 2.647 mm (Figure 12). The maximum principal stress was calculated as 1.169 MPa and it occurred at the sub of the pulleys (Figure 13). Additionally, the minimum principal stress found to be -2.755 MPa occurred at the sub of the main columns (Figure 14).

Figure 12. Maximum vertical displacement [mm]

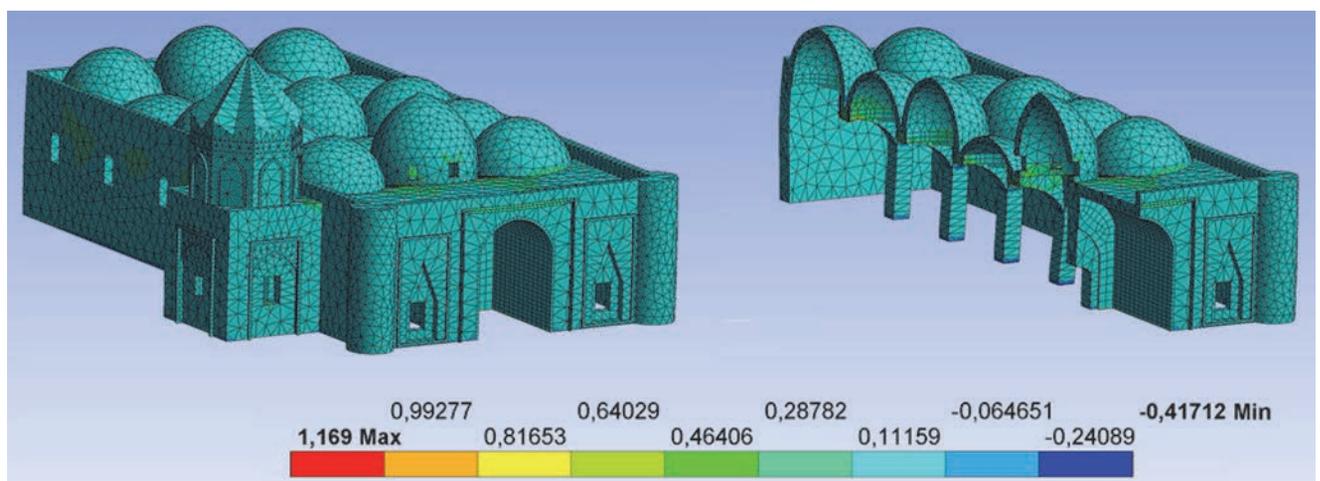
Figure 13. Maximum principal stress obtained from static analysis [MPa]

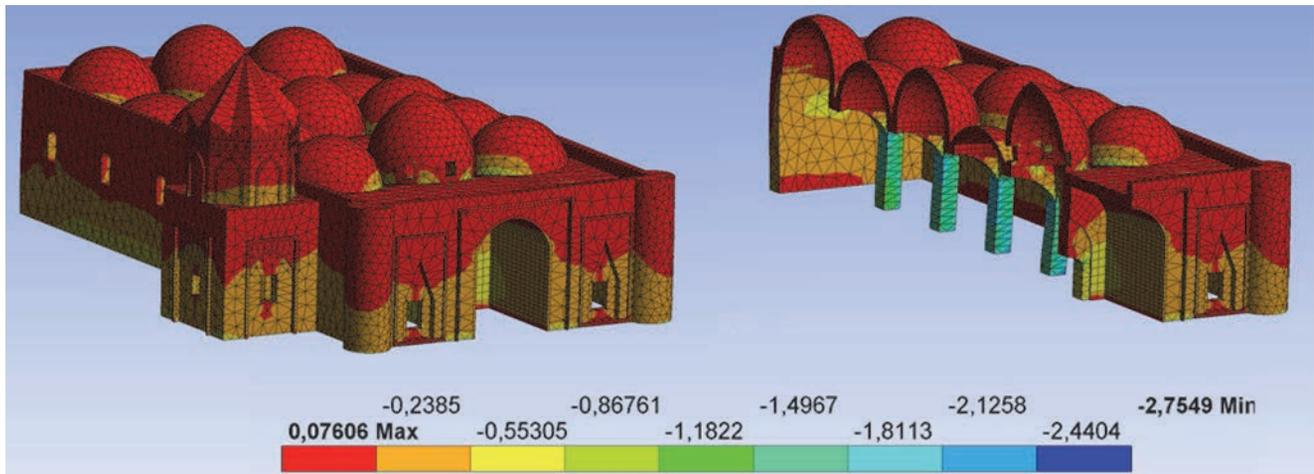
Figure 14. Minimum principal stress obtained from static analysis [MPa]

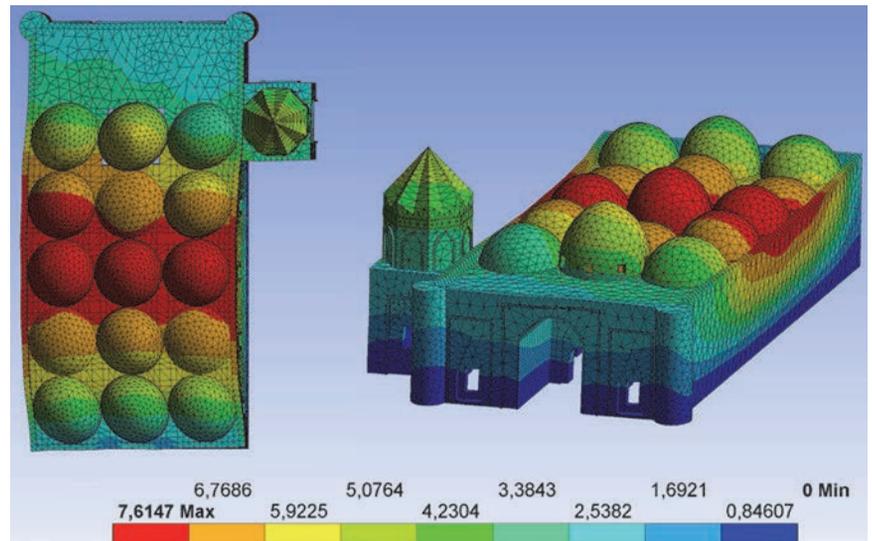
As seen from the time history analyses, the maximum lateral displacement occurred at the top of the eastern walls at about 7.62 mm (Figure 17). The maximum principal stress was found to be 4.43 MPa around the pulley of the eastern dome and the facades of the eastern wall (Figure 18). Furthermore, the minimum principal stress was found to be about 3.57 MPa around the lower parts of the main columns (Figure 19).

Figure 17. Maximum lateral displacement [mm]

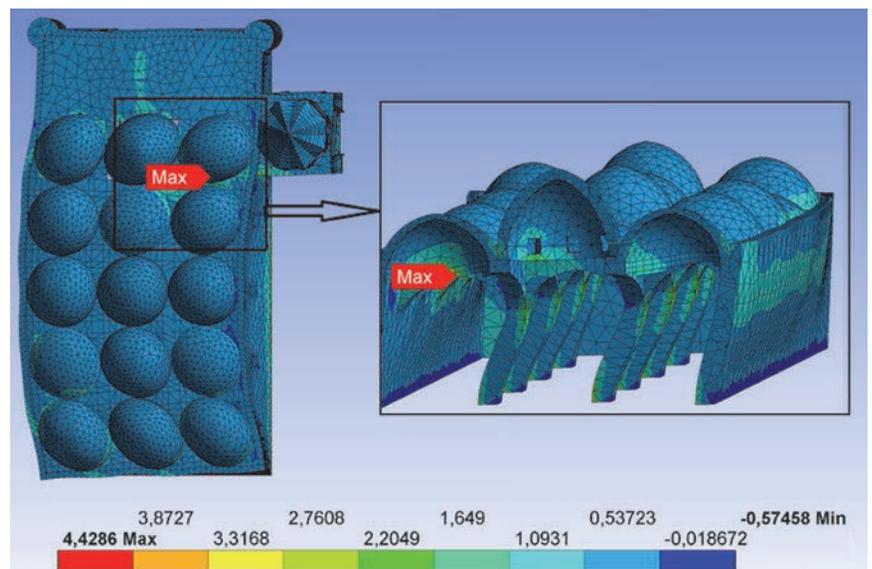
Figure 18. Maximum principal stress obtained from time history analysis [MPa]

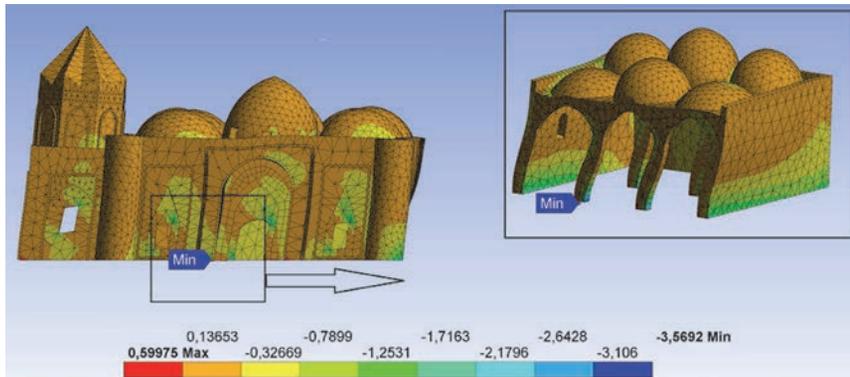
Figure 19. Minimum principal stress obtained from time history analysis [MPa]
