# Time-dependant stability of slopes excavated in marl

Prof. **Predrag Mišćević**, PhD. CE  
University of Split  
Faculty of Civil Engineering, Arch. and Geodesy  
Department of Geotechnical Engineering  
[predrag.miscevic@gradst.hr](mailto:predrag.miscevic@gradst.hr)

**Goran Vlastelica**, B.Sc. CE  
University of Split  
Faculty of Civil Engineering, Arch. and Geodesy  
Department of Geotechnical Engineering  
[goran.vlastelica@gradst.hr](mailto:goran.vlastelica@gradst.hr)

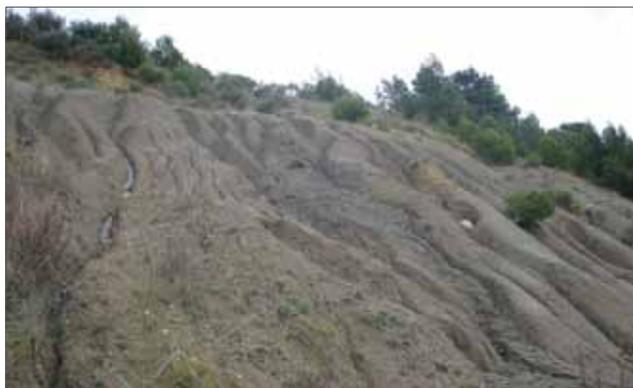
Figure 1. Marl degradation on the cut slope surface at the Adriatic Coastal Road (at Podstrana)

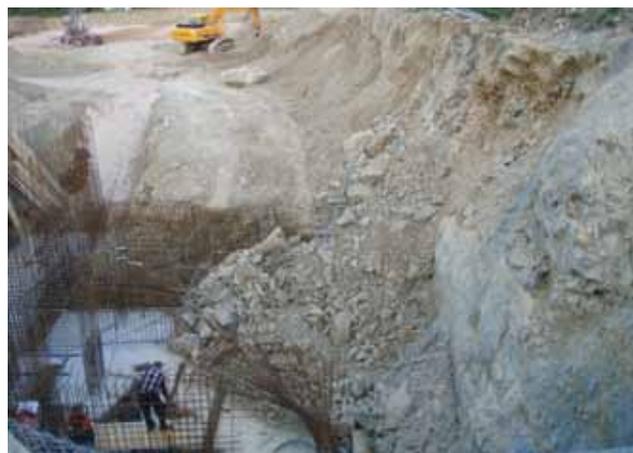
Examples of impact of weathering processes on slope stability at unprotected side cuts can be found on many locations in engineering practice. For instance, such situations are quite frequent in the vicinity of Split when excavations are made in flysch material. In the foundation pit, made for a medical school in Split (location: Trstenik), the landslide formed several months after excavations is shown in Figure 2. Fortunately, the landslide occurred during the night time and so lives of

workers at the foundation pit bottom were not put to danger. An example of landslides that are quite frequent near Split at natural cliffs in flysch formations along the coast is shown in Figure 3. The sliding process is continuous. The material deposited at the bottom of the slope is carried away by the sea and thus the space is liberated for the next "sliding phase". A formation of greater sandstone blocks at a natural side cut in flysch formations, which is also caused by marl weathering, is shown in Figure 4. The weathering rate of sandstone layers within the flysch structure is not the same as the weathering rate of marl formations. By marl layer weathering above and below sandstone layers, the marl disintegrates and is gradually removed by the action of gravity and precipitation [1-2], i.e. we witness here the process of differential weathering. Sandstone layer outcrops remain on slopes as a kind of an "cantilever" and, when the length of this overhang becomes sufficient, the blocks detach due to bending action and the resulting rockfall poses a serious threat to the zone at the bottom of the slope.

Figure 2. Collapse of slope in foundation pit excavated in marl (Split, location: Trstenik)

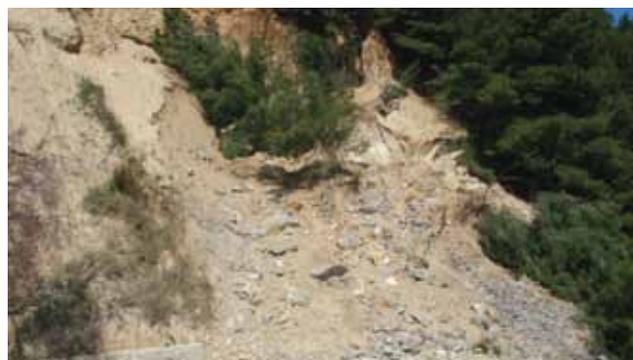
Figure 3. Landslide along the sea coast on the natural cliff in flysch formations (Split, location: Duilovo)

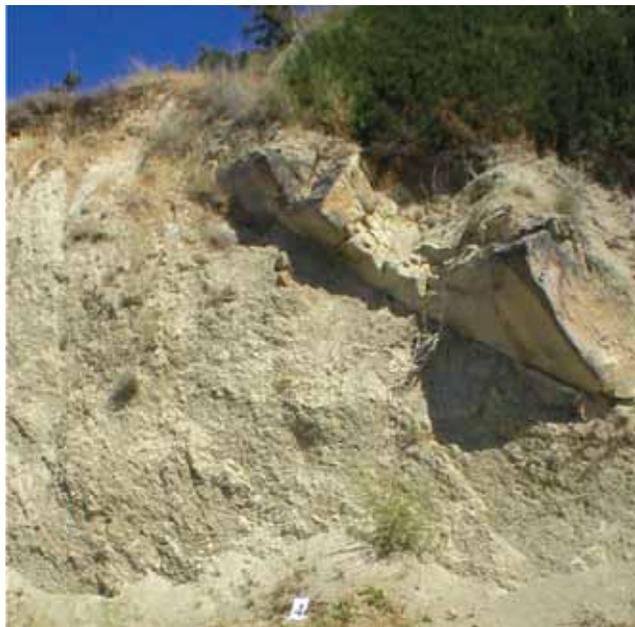
Figure 4. "Cantilever" formed of harder sandstone layer on the slope (differential weathering along the slope)

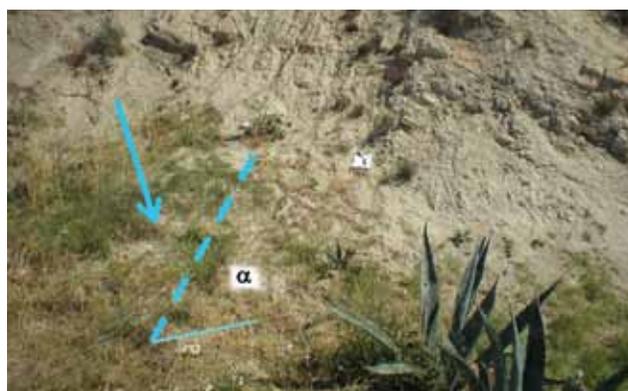
Figure 6. Measured inclination of weathered marl material deposited at the bottom of the slope (arrow), inclination range:  $\alpha = 31^\circ$  do  $38^\circ$

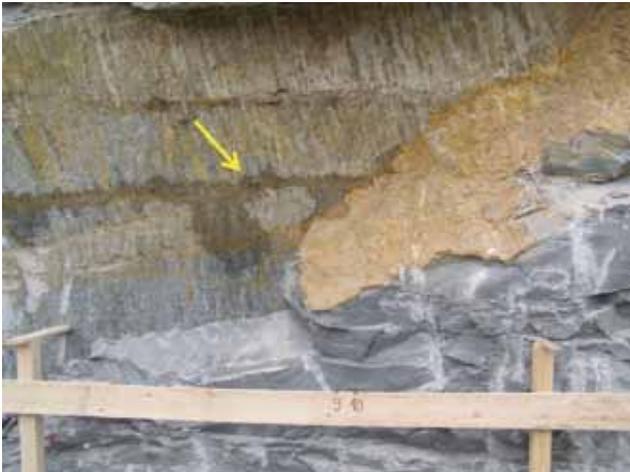
Figure 9. Water seepage through joints formed in flysch

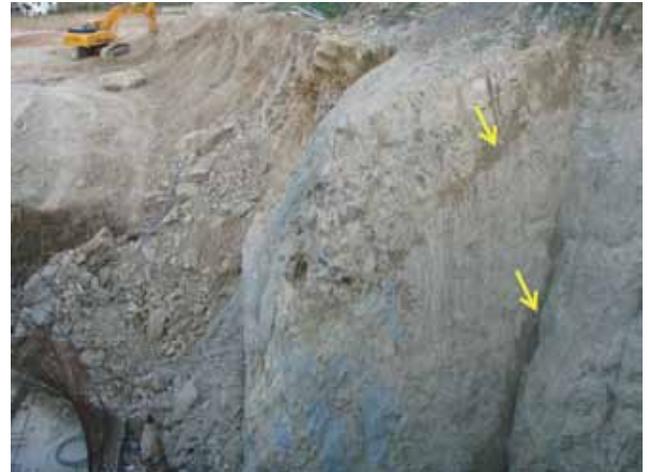
Figure 10. Seepage through secondary joints along which the sliding occurred

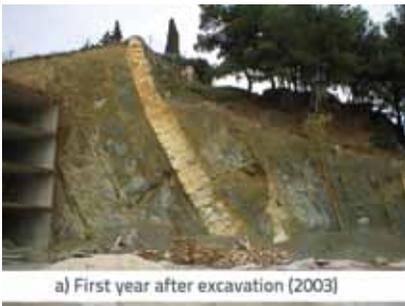
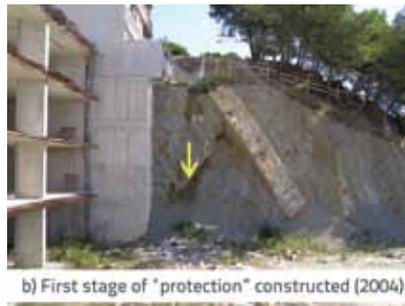
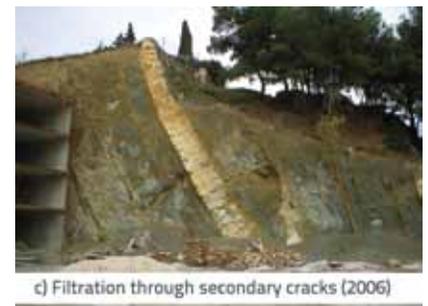
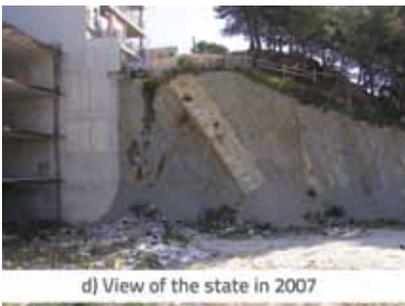
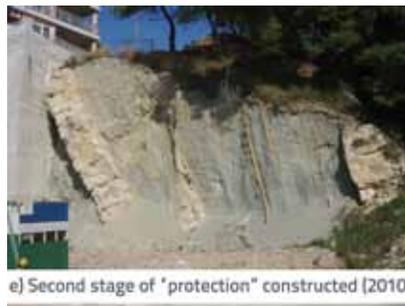
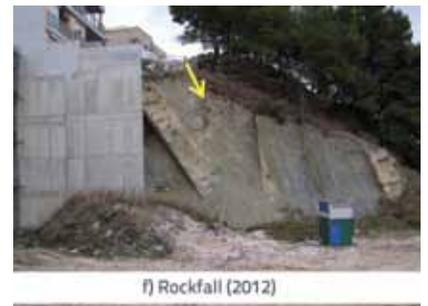
Figure 11. Slope at Žnjan district in Split in the period from 2003 to 2012

a) First year after excavation (2003)

b) First stage of "protection" constructed (2004)

c) Filtration through secondary cracks (2006)

d) View of the state in 2007

e) Second stage of "protection" constructed (2010)

f) Rockfall (2012)

Both of the above described forms of weathering are documented with a number of pictures of the same slope in flysch formations, which were taken during the observation period of 9 years after the excavation (Figure 11). The quantity of material that detached from the slope surface can be noticed as material accumulated at the bottom of the slope. This material had been removed on several occasions during the observation period. The "depth" of the surface part of the slope that was eliminated from the surface through weathering can easily be noticed as the change in the length of the harder sandstone layers "overhanging" from the slope surface. This sandstone had been initially excavated to the same levels as the surrounding layers, but was not eliminated with weathering. It can be concluded that the weathering rate

in this example is: 0.8 meters of the sandstone overhang / 8 years = 10 centimetres per year. The observations made on similar slopes have shown that the minimum depth of the material disintegrated from the surface of cut slopes in Dalmatia amounts to 1-2 cm annually.

The sliding and weathering caused by seepage through joints can be seen on the given example at the left side of the slope. Several greater blocks, formed at joints through which the water penetrated, have over time been affected by sliding. The arrow in Figure 11 shows the position of the last material fall. In 2004 and 2010, the concrete protective structure was extended in order to protect the man-built facility situated above the cut slope, as the foundations of this facility were endangered by weathering and disappearance of

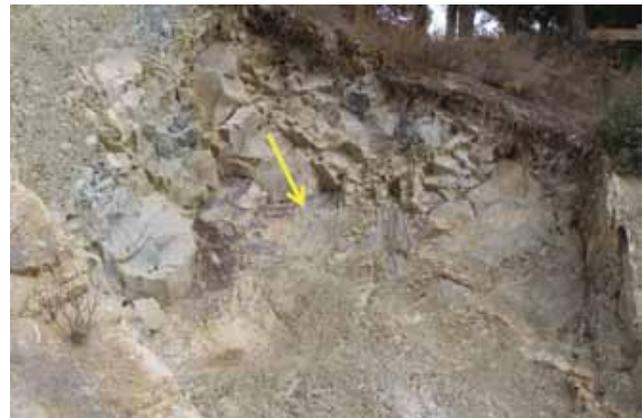
secondary joints (Figure 12), random joints or joints formed by weathering, and through basic material (marl). An example of landslide along secondary joints is shown in Figure 13 (enlarged detail from Figure 11g). The fact that the water seeps through these joints is proven by plant roots (marked in the Figure) which follow the spreading of such secondary joints.

Figure 13. Sliding along secondary joint set
