Assessment of structural performance of historical Ishan church

Professional paper

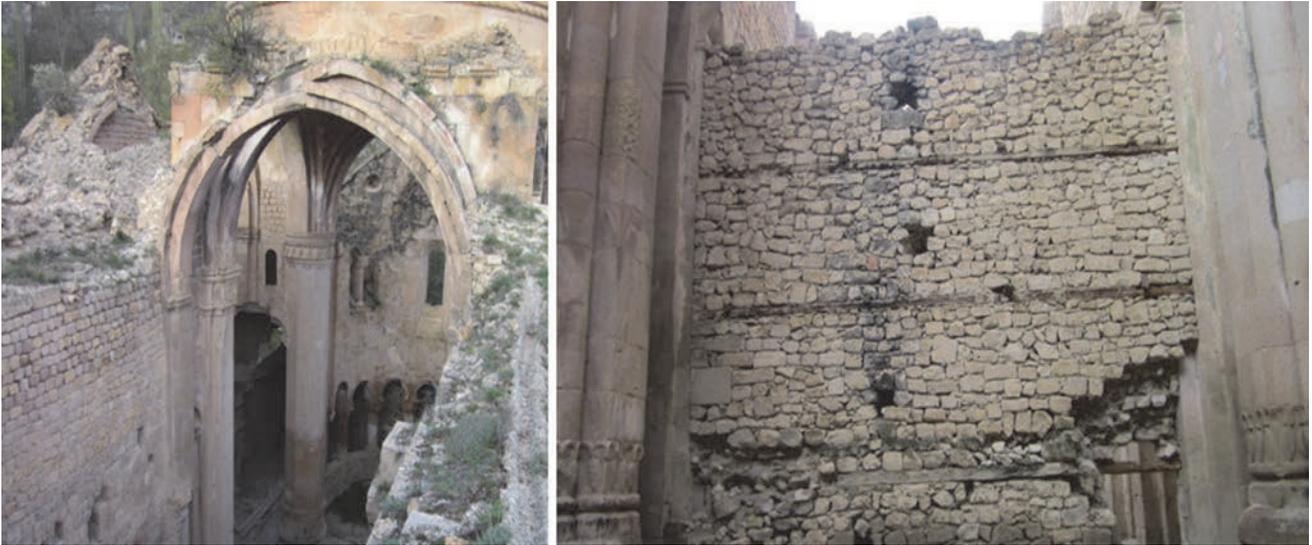
Figure 3. Partition wall built when the church served as a mosque

The west arm of the church is three times longer than the other cross arms. The church served as a mosque for several years and a separator wall was built between the west cross arm and main centre to divide the structure into two parts at the west arm (Figure 3). Two entrance doors at the south and west arms were closed in the period when the structure served as a mosque. The south door was used as a mihrab (a niche in a mosque pointing to the direction of Mecca) of the mosque, while the west door was used as the community place. However, the structure is abandoned and is currently not in use.

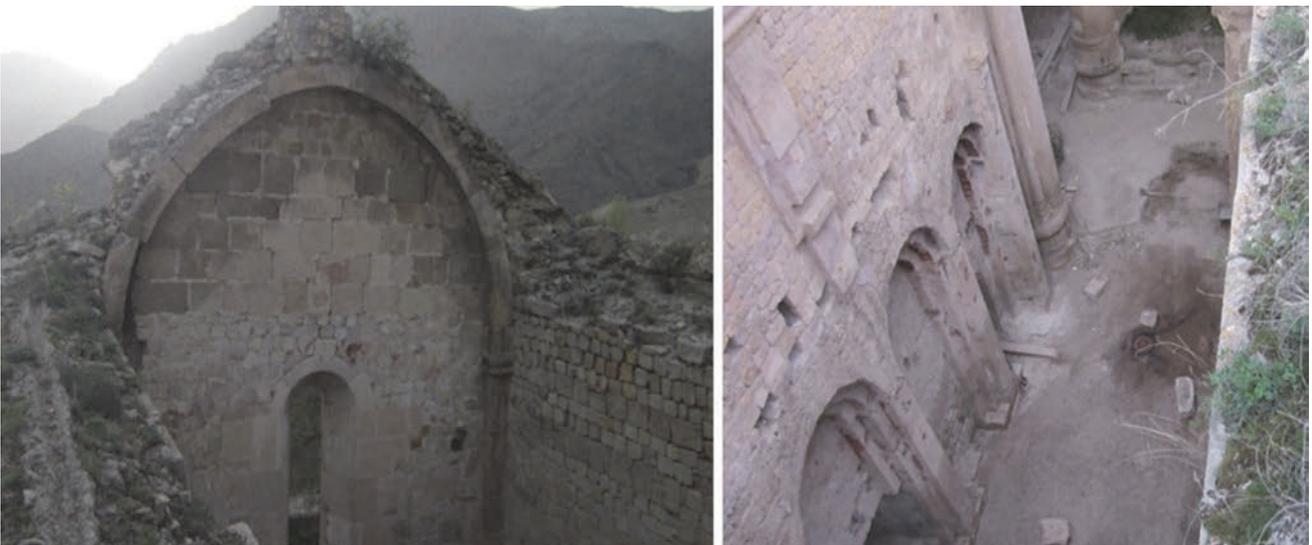
Figure 4. View of the west arm of the church and completely demolished roof

due to environmental conditions, lack of proper care, and general dilapidation. The tile roof, main arches that carry the roof, and the vault superstructure, are completely demolished and the structure is in an unprotected condition (Figure 4).

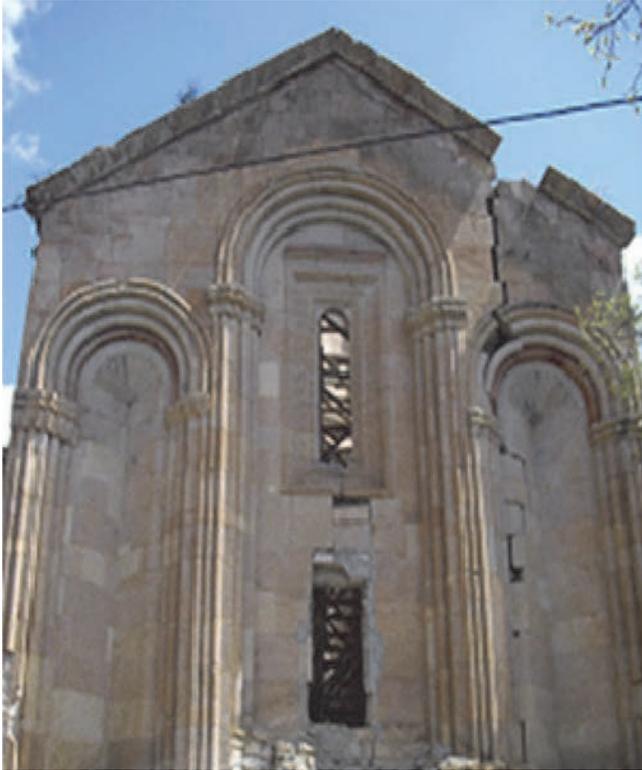
Figure 5. The view of the detached west wall and the south wall

Furthermore, several different-size mature cracks were detected on the upper parts of walls of the structures, and in different zones. A notable example is one significant crack on the west façade that runs along the height of the wall (Figure 5). Therefore, this crack is the greatest threat to the structure's safety since it significantly separates the two walls.

This significant wall that connects the west wall and the south wall stretches from the upper part of the wall to the foundation. On-site measurements have revealed that the crack width varies between 2 and 15 cm, and the crack caused a gap between the south wall and the west wall. Figures presented in Takaichvili's studies, conducted in 1952 and 1960 [1, 2], show that the crack on the west side existed already in 1917, and that the width of that crack is similar to the width of the present-day crack (Figure 6). Nevertheless, the pictures also show that the demolished vault did not exist in 1917 and that these sections were covered with a wooden roof during the period when the structure served as a mosque. It can therefore be stated that the west façade cracks and vault deformations occurred at least 100 years ago and that these deformations have not changed to this date.

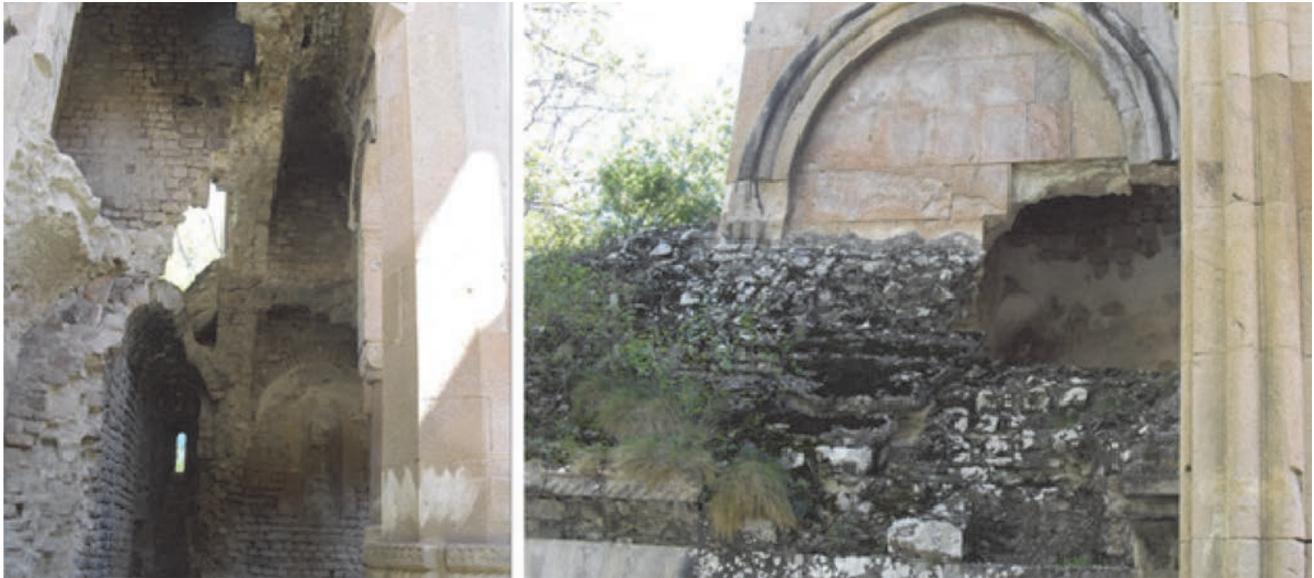
The upper parts of the apse at the east arm are totally demolished, and pastophorion rooms on the sides of the apse are heavily demolished. Vaults connecting pastophorion

rooms to the apse are completely demolished, as can be seen in Figure 7. Some small cracks can be seen on the east façade of the structure, mostly in upper parts. The repair and reinforcement studies must concentrate on the entire supporting system, and on the deep crack on the west side. Moreover, drainage excavations prove that the foundation soil is in a good condition, and that there is no significant damage to the structure's foundations.

Figure 7. Demolished vault roof of pastophorion rooms, and external view of gallery section

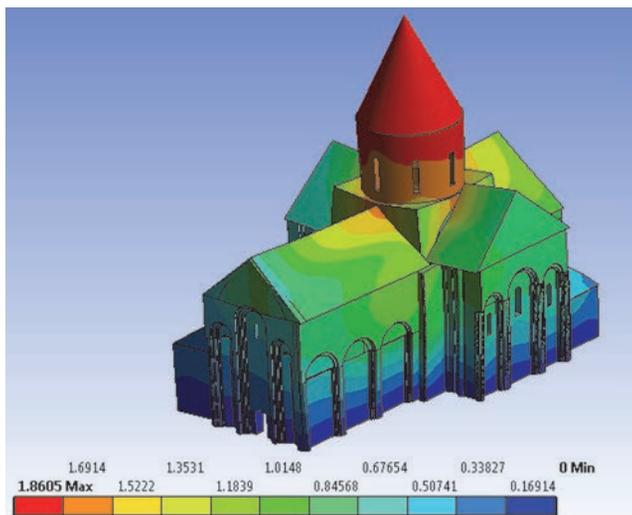
This study primarily focuses on the static analysis of the Ishan Church under its own weight, which is why the vertical load analysis was conducted. The analysis results show that the maximum displacement occurred vertically and at the conical section of the church. The maximum value of 1.86 mm was obtained (Figure 10).

Figure 10. Vertical displacements of the church, dimensions in [mm]

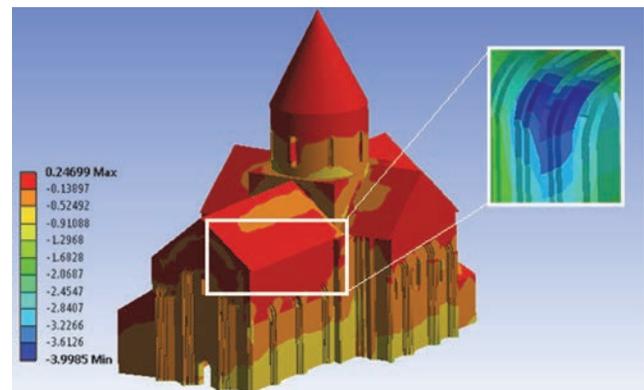
The examination of the compression and tension stress values proves that the maximum compression strength occurred at the bottom parts of main supporting columns, and at the bottom parts of the main columns that carry roof tiles. The maximum value amounts to 3.99 MPa (Figure 11). Tensile stresses are highly pronounced at the skewbacks of the arches, and side walls, and also

Figure 11. Compression stress contours obtained by static analysis, dimensions in [MPa]

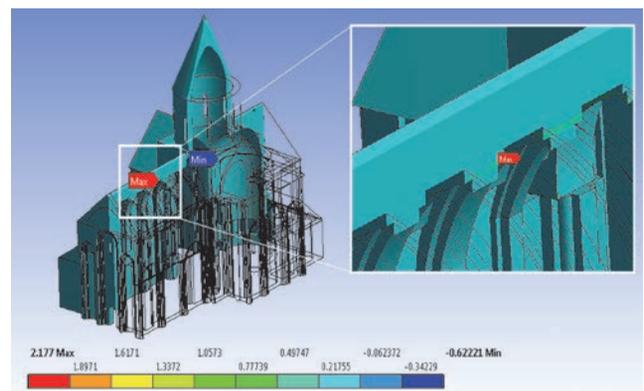
at the cone shaped supportive arches. Furthermore, enforcements were observed at the bottom parts of the arches, and the maximum tensile stress attained the value of 2.18 MPa (Figure 12).

Figure 12. Tensile stress contours obtained by static analysis, dimensions in [MPa]

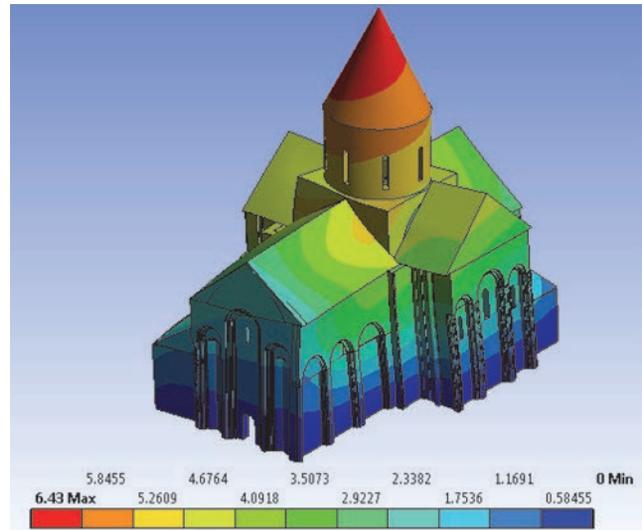
Figure 17. Lateral displacement contours through dynamic analysis, dimensions in [mm]

The analyses results show that the maximum horizontal displacements take place at the main dome of the church, and at top parts of the main entrance, attaining as much as 6.43 mm at the main dome (Figure 17). The critical stresses generated through the analyses are observed primarily at the supports of hanger arches that carry the main dome and the surroundings of the window spaces. Tensile stresses are particularly pronounced at arch supports that carry the dome, and at the bottom parts of supportive columns. Third principal stresses appear as compressive stresses, and are especially notable at the bottom and upper parts of supportive columns. In addition, stress increases can be noted at the bottom parts of the main dome, and the maximum compressive

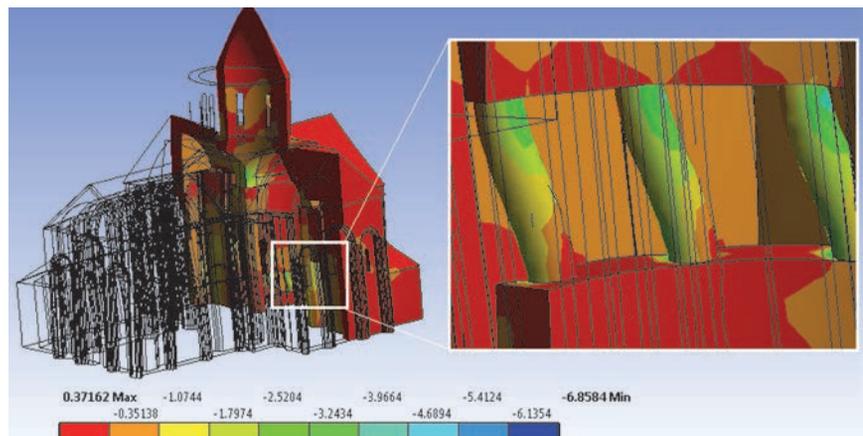
Figure 18. Compression stress contours through dynamic analysis, dimensions in [MPa]

strength attains 8.06 MPa (Figure 18). Tensile stresses are also observed at arch supports that carry the roof vault in the west arm, and at the upper parts of the main supporting elements, attaining the value of 3.00 MPa (Figure 19).

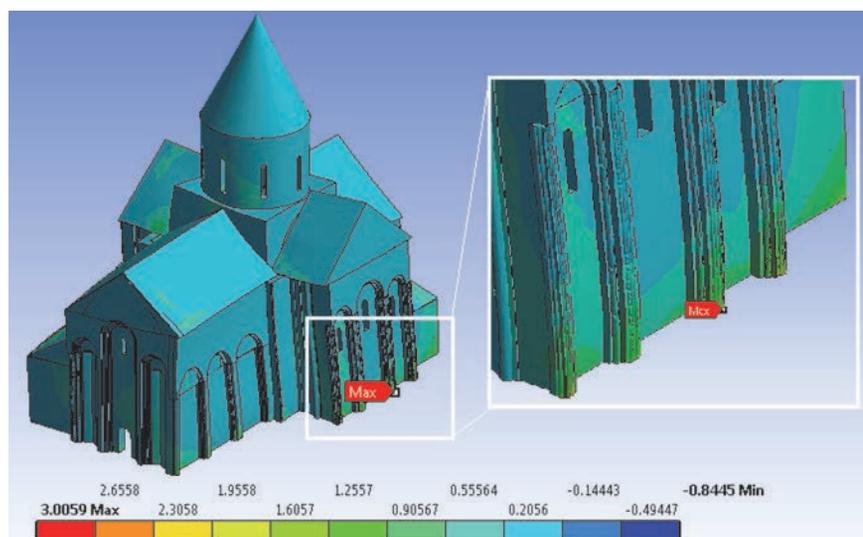
Figure 19. Tensile stress contours through dynamic analysis, dimensions in [MPa]
