Specific features of diaphragm for Trebež landfill improvement in Samobor

Professional paper

The diaphragm forming a vertical barrier for preventing the spread of pollution from Trebež landfill (Samobor) is a buried clay-concrete structure measuring 698 m (length) and 0.8 m (width) in plan. The design and realisation requirements are described, and the entire construction process, involving design, preparatory work, construction, and quality control, is presented. Realisation of the vertical barrier is the most demanding and the costliest element of the Trebež landfill improvement project. Disturbances and challenges encountered during realisation of the barrier are presented, with a special emphasis on verticality.

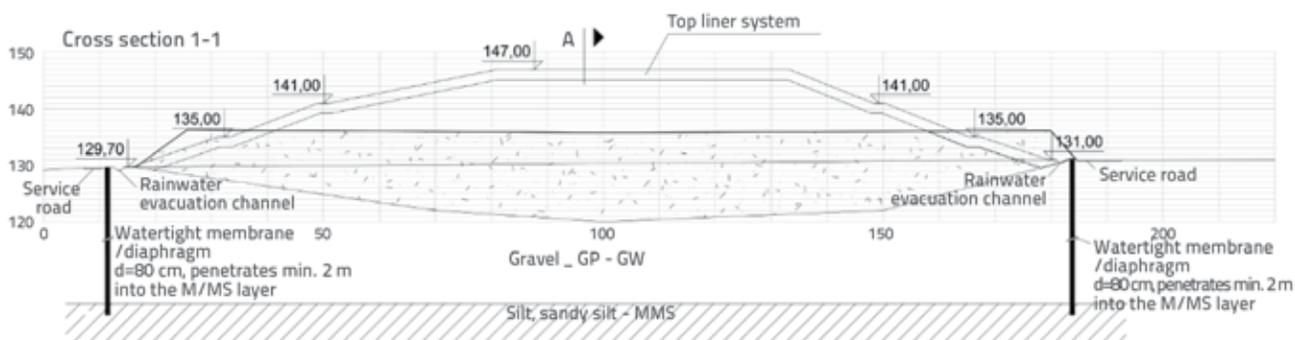
Figure 1. Typical cross section planned for Trebež waste site [4]

The typical cross section of the site was defined in the preliminary design, as shown in Figure 1 [4].

The diaphragm had to be realized in such a way to penetrate no less than two metres into the weakly permeable compacted silty sand layer with the permeability ranging from $k = 3,8 \times 10^{-10}$ to $1,0 \times 10^{-9}$ m/s. According to the client's requests, the water permeability ratio of the diaphragm had to be $k < 1 \times 10^{-9}$ m/s.

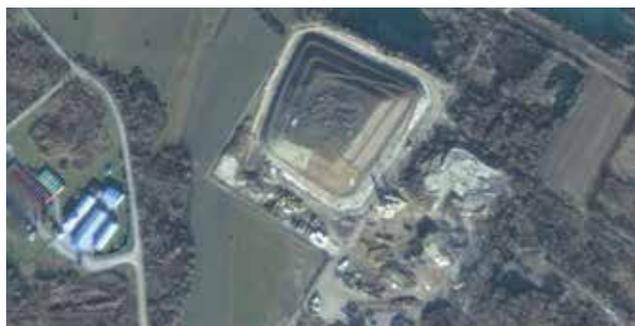
Figure 2. Satellite image of the Trebež waste site during remedial activities (photo taken on 25 December 2015), source: Google Earth

The waste site body occupies an area of 33,00 square metres. The volume of the waste body on the surface of the waste site amounts to 290,000 m³, while the volume of the entire waste site body, including the cover system, amounts to 330,000 m³. A satellite view of the waste site body during realisation of waste site sides is shown in Figure 2.

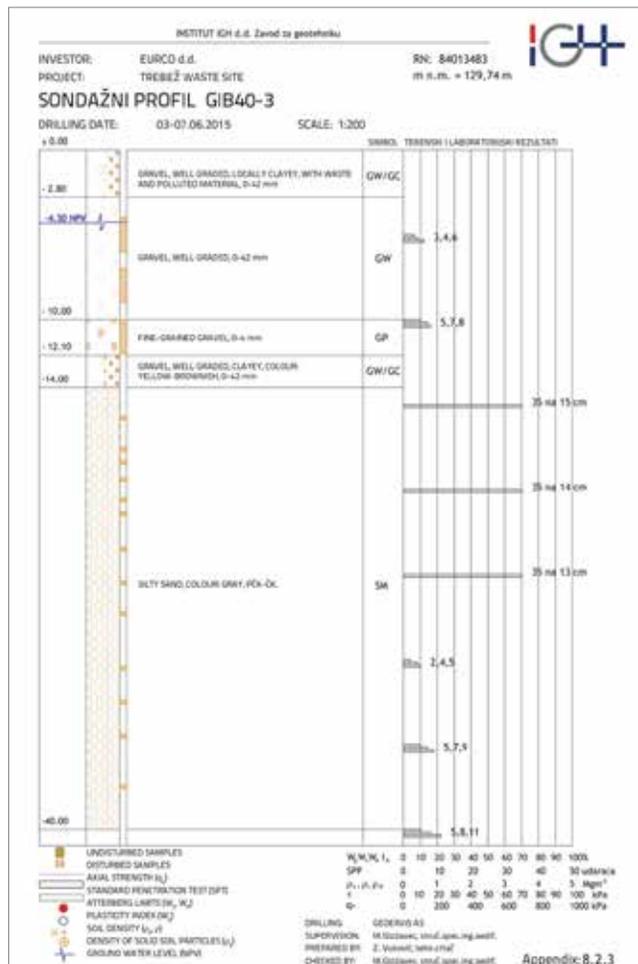
Composition of natural soil at the waste site is presented in Figure 3. The soil is divided into the following three basic layers:

Figure 3. Typical soil profile

- Soft to firm low plasticity clay mixed with gravel. According to borehole results, individual layers vary from 1.40 to 4.40 m in thickness. As gravel had been extracted from this site prior to the disposal of waste, it is possible that this layer was locally deposited on this site. This assumption is based on local discoveries of construction waste or garbage at greater depths.

- Stiff to solid locally clayey gravel or stiff to solid gravel with traces of silt and sand. In the top zone, it occurs as a well graded gravel, while in bottom parts it occurs as clayey gravel or as grey gravel with traces of silt and sand. An interstitial fine gravel layer (0-6 mm, max. 18 mm in grain size) occurs in various thicknesses between the well graded gravel and the clayey gravel or grey gravel with traces of silt and sand. The angle of friction and SPT correlation was applied to determine layer strength parameters (GW/GP/GM). For the median SPT value ranging from $N = 13$ to $N = 28$, the selected parameter value amounts to $c = 0$ kN/m², $\varphi = 32^\circ - 35^\circ$.

- Stiff to solid silty sand. It contains approximately 70 % of sand and 30 % of fine silt and clay particles (silt 20-25 %, clay 5-10 %). The layer varies from 14.0 to 27.50 m in depth. The layer thickness can not be unambiguously defined. The angle of friction and SPT correlation was applied to determine layer strength parameters (SM). For the median SPT value of $N = 35$, the selected parameter value amounts to $c = 0$ kN/m², $\varphi = 38^\circ$. The values of the order of magnitude $k = 10^{-7}$ m/s and $k = 10^{-8}$ m/s were obtained by on-site permeability testing using the SLUG method. Laboratory testing of soil permeability was also conducted in oedometer on disturbed samples. The values obtained range from $1,1 \times 10^{-8}$ m/s to $3,75 \times 10^{-10}$ m/s.

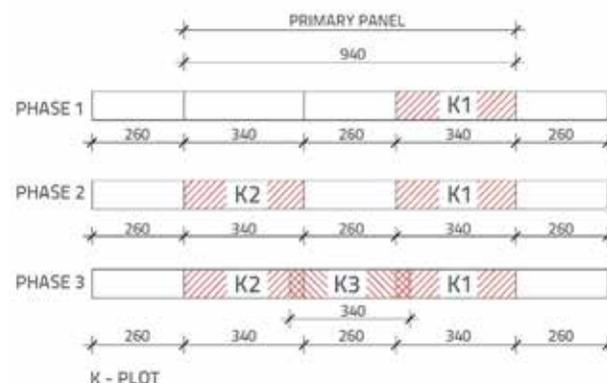
A cable excavator, with open/closed clamshell bucket 3.40/2.43 m in length and 0.8 m in width, was used in diaphragm excavation. Primary panels were 9.4 m in length, while the length of secondary panels amounted to 2.6 m. A primary panel is formed of three plots 3.4 m in width, with the central plot cutting into the previously realised side plots (Figure 4).

Figure 4. Primary panel excavation plan

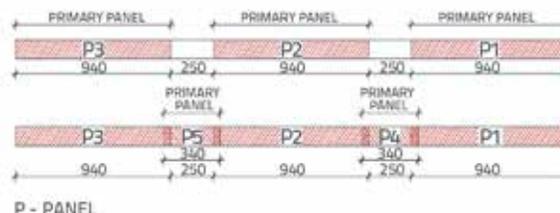
The cutting of individual plots and panels was carried out in the length of 0.4 m. According to the realisation plan (Figure 5), the activity starts by realisation of primary panels (P1, P2 and P3), and continues with secondary panels (P4 and P5). The basic plan for realisation of primary and secondary panels is presented in Figure 5 (adopted from the subcontractor STEIN HT GmbH Spezialtiefbau, and incorporated in the working design for the diaphragm [8]).

Figure 5. Arrangement of primary and secondary panels

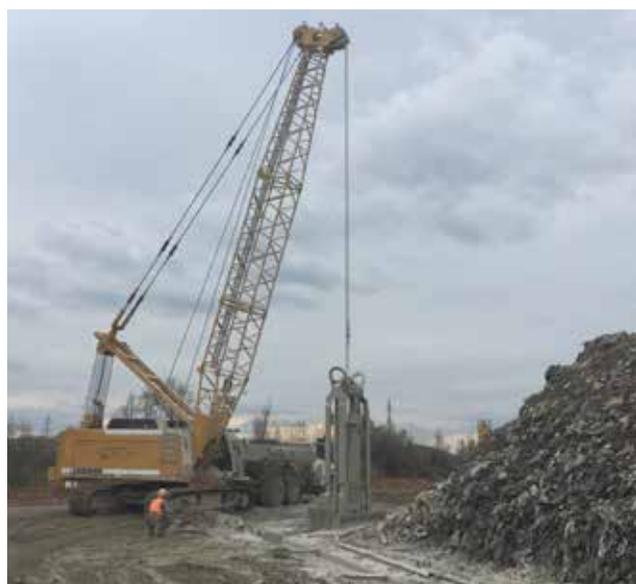
The inlet channel is 83.5 cm in width. The portable entrance funnel is 83.5 cm wide in its narrowest part, and exceeds by 3.5 cm the bucket width, which is quite necessary as the bucket must be able to move – without any hindrance – to the excavation plot. The mobile entrance funnel is mounted at the top of the inlet channel and it assists the operator to accurately guide the bucket into the excavation pit (Figure 6).

Figure 6. Equipment for excavation of diaphragm, inlet channel and entrance funnel

As to verticality of diaphragm plots, it was specified that the deviation should be less than 0.2 %. The achievement of diaphragm verticality was facilitated by the inlet channel (two parallel concrete walls realized along the waste site perimeter), portable steel-made entrance funnel, and equipment for continuous monitoring of verticality. The achievement of diaphragm verticality was also facilitated by the bucket operating height of no less than 11.2 m.

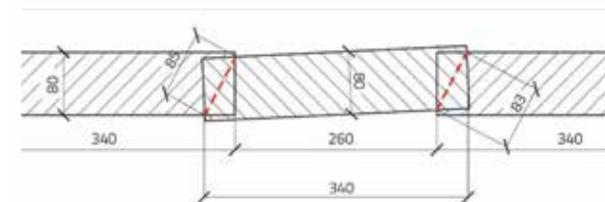
The link between individual plots, necessary to achieve watertightness and continuity, was realized by panels cutting one into another. The system for monitoring verticality of excavation work is used to continuously check that this plot cutting/overlapping is sufficient. The following acceptable plot overlapping criterion has been adopted: the diagonal between two opposite edges of neighbouring plots must have the length that is longer or equal to the nominal width of the diaphragm (Figure 9).

Figure 9. Criterion of sufficient plot overlapping/cutting for ensuring proper diaphragm continuity

The main criterion for ensuring continuity of the diaphragm is representation of the cutting of plots (and panels) in such a way that the cutting diagonal has the same or greater length compared to the diaphragm length (see Figure 9). During the realisation stage, the contractor demonstrated – by bucket path measurements – that this criterion was met along all diaphragm plot and panel connections. The following technical deficiencies of the criterion that defines deviation from the vertical were noted:

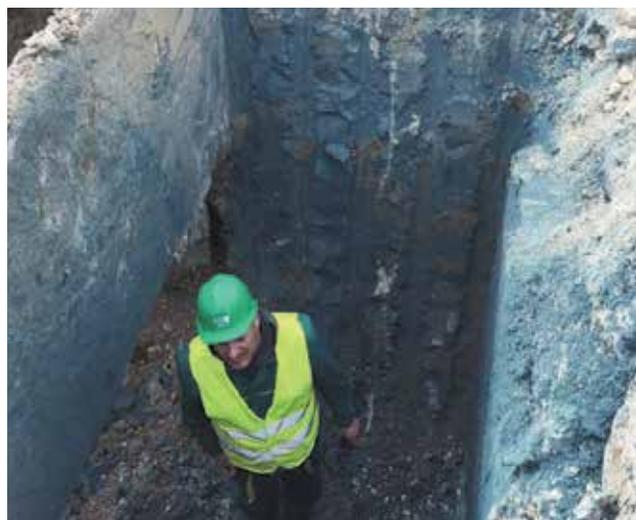
not exceed 5 mm. After inspection of the excavation (Figure 10), it was concluded that the mixture filled in all pores in soil that were formed under the contour of the inlet channel created by the bucket. In fact, soil detached from the inlet channel wall and the fresh plastic concrete mix successfully filled in the detached volume of soil. Visual inspection made at the trial excavation site revealed that the seepage water did not affect quality of the plastic concrete mix as the colour of the hardened plastic concrete was uniform, without dark stains (that would point to the passage of seepage water), and all inspected surfaces of the plastic concrete excavation were hard.

Figure 10. Trial excavation for checking penetration of plastic concrete mix into the surrounding soil

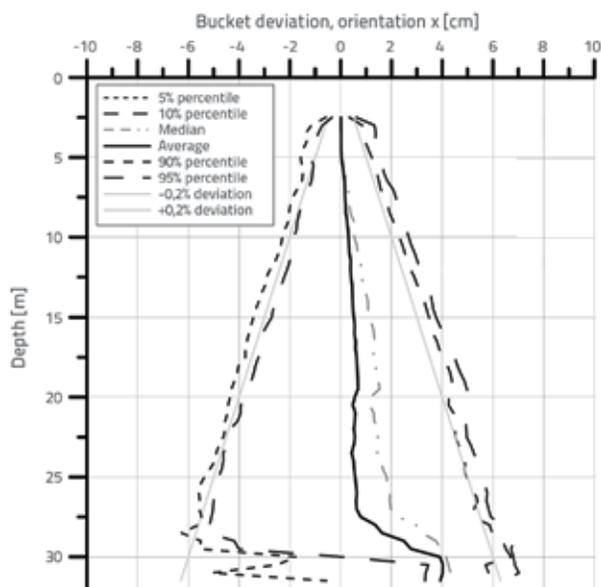
Figure 11. Deviation of excavation from vertical in the x direction

The x direction is the deviation from verticality along the diaphragm route. Figure 11 shows 5 %, 10 %, 90 %, and 95 % of the percentile of deviation in the x direction, median, average deviation, and allowable deviation (0.2 % of the depth).

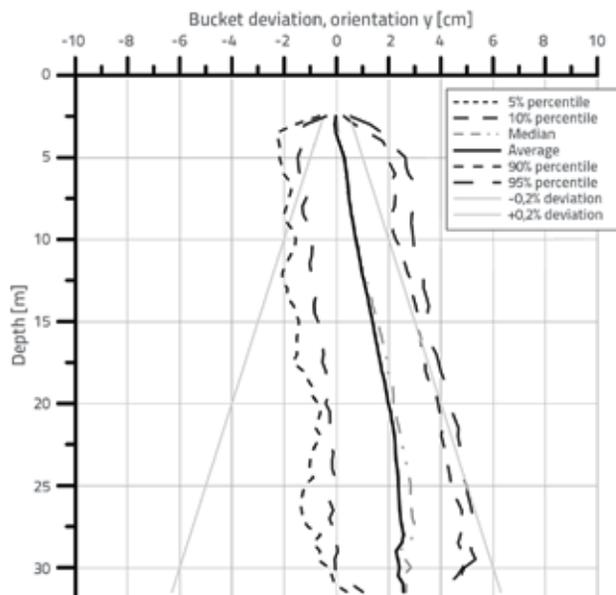
Figure 12. Deviation of diaphragm excavation in the y direction

The y direction is perpendicular to the diaphragm plot spreading direction. The deviation of excavation in the y direction along the depth is shown in Figure 12. It can be observed that, at the depth of 8 m, more than 10 % of registered deviations have a deviation in the y direction that is greater than the spacing between the inlet channel and bucket width, i.e. that is greater than 1.75 cm in the positive and negative directions (i.e. 3.5 cm in total). The greatest deviation of the bucket path was measured in the first 7 meters of the excavation, which can be neglected as the bucket is not in the inlet channel for the full depth, and the tolerance provided by the width of the inlet channel covers such deviations, i.e. the minimum width of the diaphragm is 83.5 cm at the depths of less than 7 meters. Thus, the deviation of excavation gives a wrong impression of possible “deviation” while, in reality, it is a widening of excavation until the edge of the inlet channel.

There is a clear tendency of excavation turning toward a positive direction, i.e. toward the waste site body, and away from the cable excavator. With an increase in depth, this tendency of average deviation in the positive direction becomes more pronounced, but the dissipation of deviations reduces with the depth.

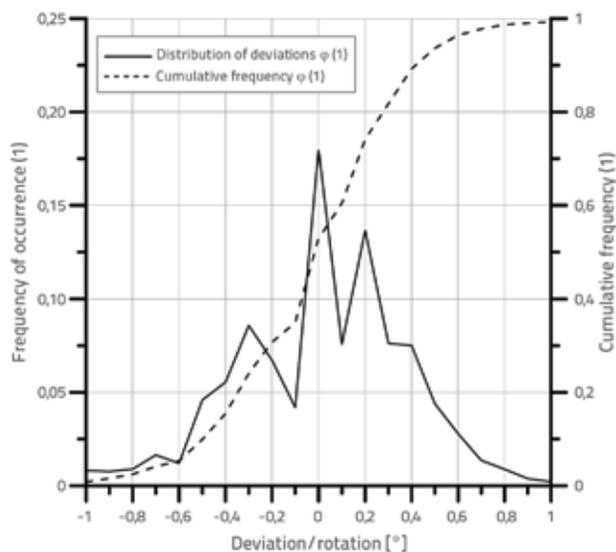
of deviations presented in Figure 13 reveals that most deviations do not exceed $\pm 1,0^\circ$ a that there is a natural tendency of bucket rotation within the excavation in the positive and negative directions.

Figure 13. Distribution of deviations caused by rotation of excavation tool

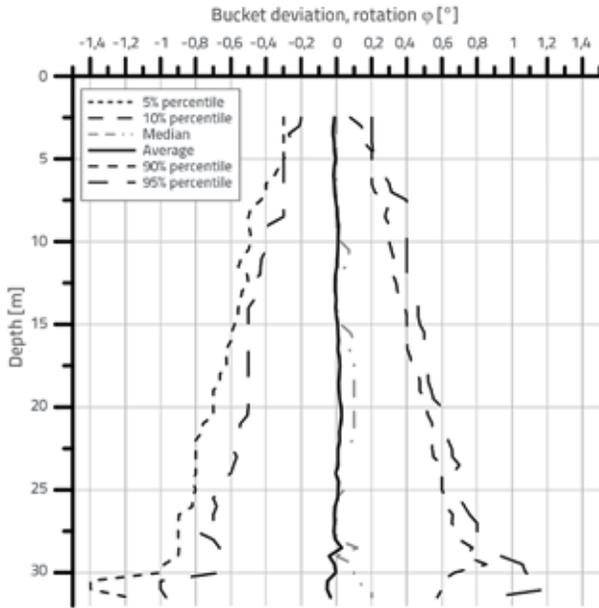
Rotation-caused deviation in excavation pit along the excavation depth is presented in Figure 14. It can be seen in Figure 14 that the difficulty of maintaining excavation parallel increases with the depth of excavation. The bucket hangs from the cable and a simple mechanism for correcting the bucket rotation around the excavation axis actually does not exist. The bucket rotation is not a problem in excavation depths that are lower than the length of the bucket. For excavation depths that exceed the length of the bucket, the bucket should have the possibility to continuously monitor and correct the rotation.

Figure 14. Deviations in bucket rotation along the depth

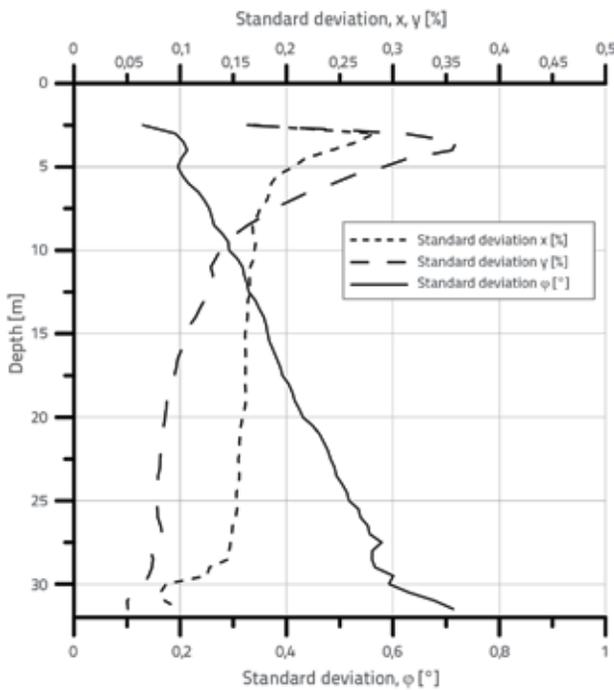
Standard deviation from verticality of excavation in the x and y directions, and standard deviation in bucket rotation ϕ , are shown in Figure 15. The deviation from the vertical in the x direction becomes balanced and reduces with the depth. The deviation from the vertical in the y direction is pronounced during the first seven meters, and reduces with the depth. The deviation in bucket rotation becomes more pronounced with an increase in excavation depth. This is due to the fact that the bucket hanging from the cable can not be controlled.

Figure 15. Deviation of excavation in the x and y directions, and in rotation along the depth

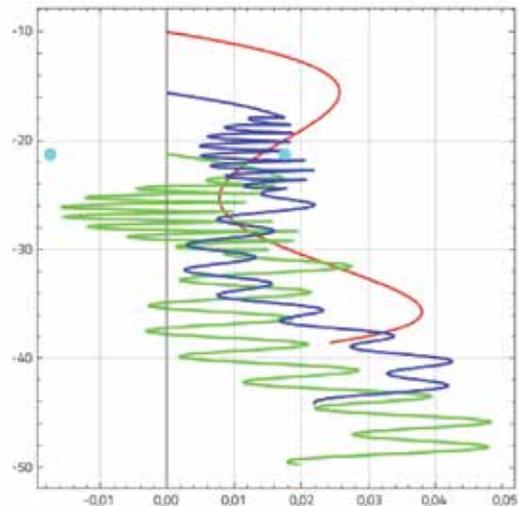
Figure 17. Result obtained by mechanical modelling of bucket movement in excavation pit

The absolute value of the vector showing the speed of motion of the top part of the bucket is constant and amounts to 0.5 m/s (this information corresponds to the speed of the bucket winch release and pull, as presented in technical specification for the bucket used in this excavation work). As the top of the bucket deviates in positive

direction in the y axis, thus also the centre of mass sways to the right. When the bucket moves along the predefined path, it hits by its bode the walls of the inlet channel, and sways (oscillates) within the space of the inlet channel. The blue dot represents the trajectory of the centre of mass, which is defined in the model with the value of 16,500 kg (from technical specifications for the bucket), while the green dot represents the bottom of the bucket. In this mathematical model, the bottom of the bucket is not an added mass. The path of the bucket body is therefore not defined by the predefined path of the bucket top only, but also by the path of its entire body and well as by boundary conditions (inlet channel). The foundation soil of the excavation pit and its properties have not been taken into account, i.e. no additional boundary condition was set with regard to bucket movement.

Bucket path results were used to create a representation of bucket movement along its path through the excavation pit. It can be concluded from interpretation of bucket top movement according to this model (Figure 17) that the excavated panel does not meet the verticality criterion ($<0,2\%$) at the depths from 0 to 8.5 m when the bucket body is mostly outside of the excavation, and the result of the movement is translated vertically to the bottom of the bucket. However, the model actually represents the widening of the diaphragm panel excavation, although the top of the bucket deviated from the criterion. The measured deviation of the bucket top from the vertical does not mean that the panel deviates from the vertical, but rather that the panel width is locally greater. The greatest widening of the excavation is registered on the model at the depth of 12 m and it amounts to 4 cm.
