Overview of integrated health monitoring system installed on cable-stayed bridge and preliminary analysis of results

Research Paper

The Junshan Yangtze River Bridge, built in Wuhan, China in 2001, is a steel box girder cable-stayed bridge with a main span of 460m. Due to decades of service, the bridge suffered gradual degradation and some damage. Structural health monitoring has attracted worldwide attention due to its capacity of monitoring structural damage, assisting maintenance and management, and ensuring safe operation of bridges. To monitor the performance status of bridges and generate a timely safety alarm, an integrated health monitoring system has been designed and implemented on bridges. This paper provides a thorough account of the monitoring system used at the Junshan Yangtze River Bridge. It mainly focuses on the selection of monitoring variables and arrangement of sensor points, the data collection and transmission system, the data storage and management strategy, and the user interface system. All kinds of monitoring data collected under daily operation, such as vehicle load, deflection, displacement, and cable tension, are analysed. Monitoring data for an extrem

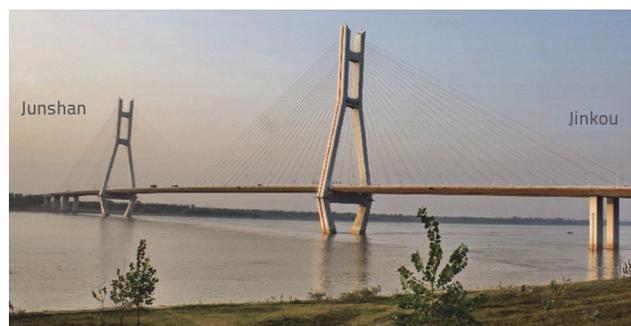
Figure 1. Layout of Wuhan Junshan Yangtze Bridge

The Junshan Yangtze Bridge, located in Wuhan City of Hubei province in China, is a semi-floating five-span continuous cable-stayed bridge, as shown in Figure 1. The bridge is a part of the highway over the Yangtze River, which connects Jinkou town and Junshan town, using the upstream side for travelling from Junshan to Jinkou. The span arrangement is 48 m+ 204 m+460 m+204 m+48 m. The main beam is a steel box girder structure 3.024 m deep and 38.3 m wide. The net width of the deck, which accommodates six lanes, is 33.5 m. The height of tower from the pile cap to the top is 163.5 m. A total of 72 pairs of cables are installed between the girder and towers. The bridge was completed and opened to traffic on December 15, 2001. Some photos of construction and components of this bridge are shown in Figure 2. With the economic development, the traffic over this bridge is very busy, and most of the traffic is composed of heavy vehicles. Due to over-loaded vehicles, environmental corrosion, material ageing, and fatigue, some damage has been established during periodic inspection, such as cracks in the steel box girder and the tower wall, and failure of some parts of the cable stay dampers. Although this damage has been repaired, new damage is likely to occur in the future. For timely identification of the operational status and provision of proper maintenance suggestions, an integrated SHM consisting of more than 300 sensors has been designed and implemented to monitor the Junshan Bridge.

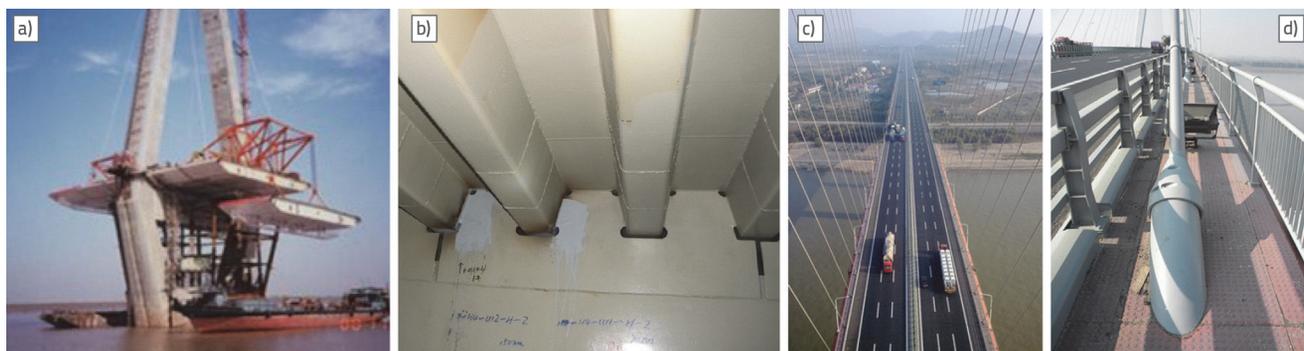
Figure 2. Details of Wuhan Junshan Yangtze Bridge: a) Hoisting of steel box girder; b) The welded detail in steel box girder; c) Deck; d) Cable

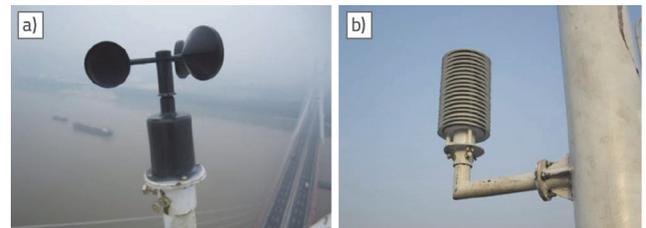
Figure 3. Anemometer and hygrometer installed on the bridge: a) Anemometer; b) Hygrometer

maintenance. They have a broad range of -55 °C to 125 °C, accuracy of 0.5 °C, and resolution of 0.0625 °C. Figure 3 shows the field photo of anemometer and hygrometer installed on the bridge.

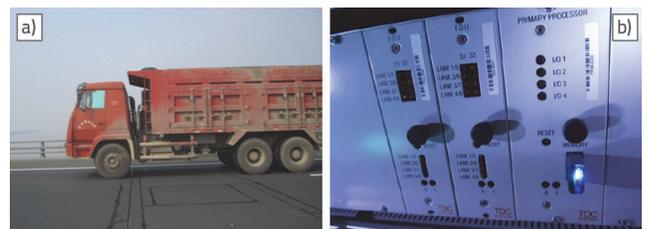
Figure 4. The WIM system installed on the bridge: a) WIM; b) Demodulator

To identify the traffic load across the bridge, a six lanes weigh-in-motion (WIM) system was installed on the deck of the bridge. The installation of the bending plate weighing system based on the strain sensor requires a big slotting on pavement and it is very difficult to maintain and replace the sensors. The vehicle detection and recognition system based on microwave and radar techniques cannot identify the weight of the vehicle. Therefore, a WIM system based on the piezoelectric film sensor was adopted in this SHM system. The adopted WIM system has a good accuracy and durability, it is easy to maintain and replace the sensors, and it inflicts little damage to pavement. Figure 4 shows a field photo of the WIM sensor and demodulator installed on the bridge.

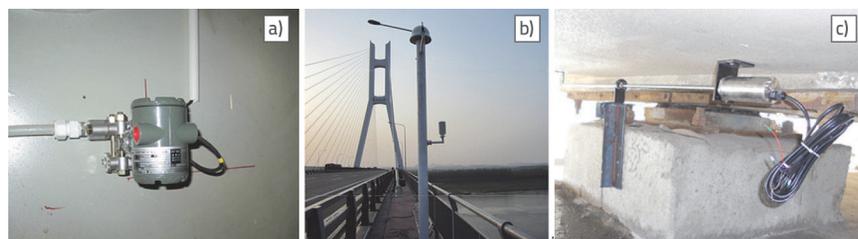
Figure 5. Installation photos of deflection gauge, magnetostrictive displacement sensor and GPS: a) Deflection gauge; b) GPS; c) magnetostrictive displacement sensor

Bearings should withstand deformations of the beam under all kinds of loadings such as the traffic load, temperature, shrinkage and creep of concrete, so that the operation condition of the bearings needs to be monitored. The long-term stability of displacement sensor of pull on the rope is not good, and it is susceptible to environmental temperature. The measuring range of the Linear Variable Differential Transformer (LVDT) displacement sensor is not large and its installation is complex. Thus, the magnetostrictive displacement sensor was chosen due to its large range (50~7600 mm), high accuracy, good long-term stability, and convenience of installation. The measuring range and resolution of the sensors were chosen according to the calculated results obtained by FEA. Figure 5 shows the installation photos of the deflection gauge, magnetostrictive displacement sensor and GPS.

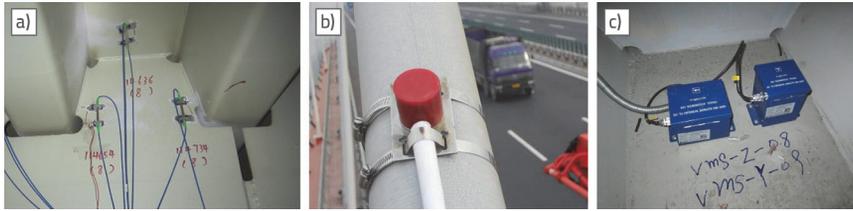
Figure 6. FBG strain gauge and accelerometers measuring cable tension and vibration: a) FBG strain gauge; b) accelerometer; c) accelerometer

Figure 6 shows the FBG strain gauge, accelerometer measuring cable tension, and accelerometer monitoring vibration of the bridge. The monitored variables and the types of sensors are summarized in Table 2, and the general arrangement of the measuring points is shown in Figure 7.

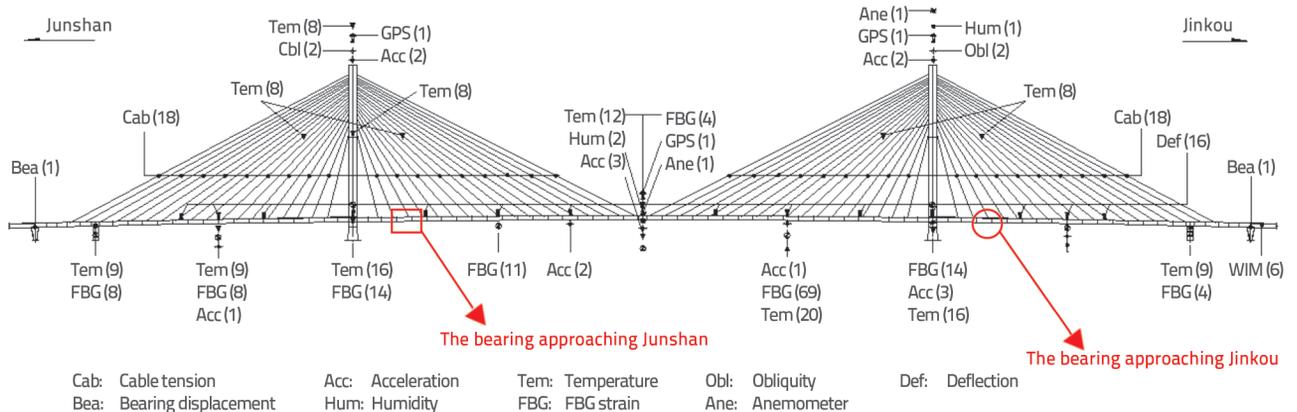
Figure 7. General arrangement of all measuring points at Junshan Bridge

As shown in Figure 7, quite a few FBG strain gauges are installed at individual sections along the steel box girder to monitor the structural stress response. In each section, four measuring points are arranged on two steel webs at the downstream and upstream, and two measuring points are installed at the top and bottom of each steel web, as shown in Figure 27.

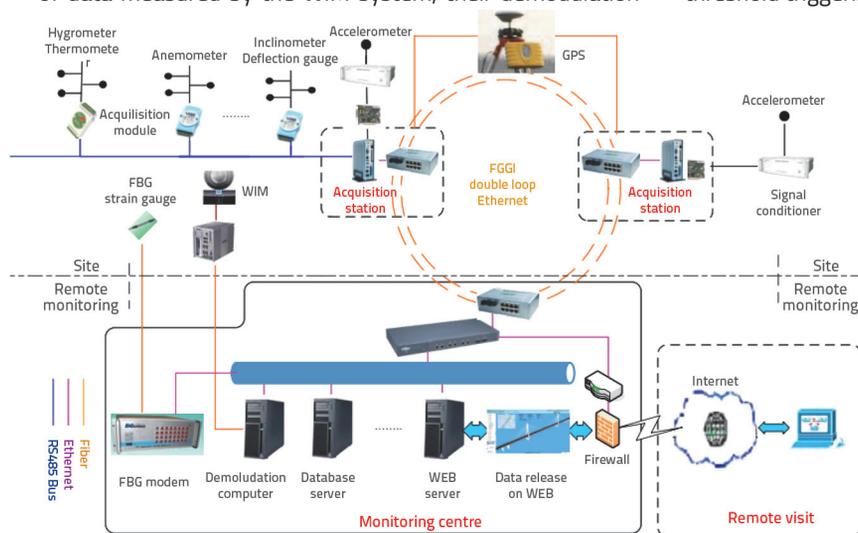
Figure 8. General collection and transmission network of Junshan bridge

The entire data collection and transmission network of the Junshan Bridge is shown in Figure 8.

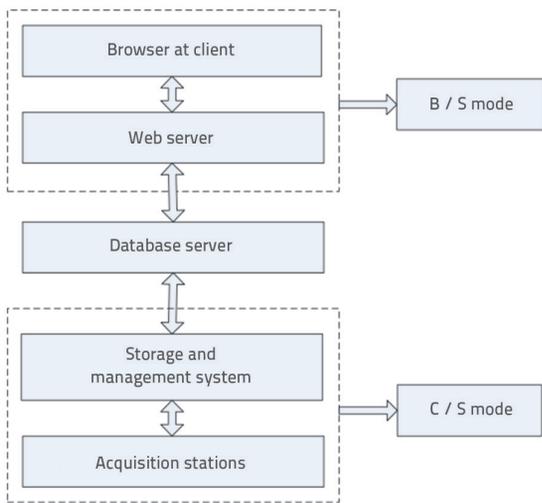
Figure 9. Mode of user interface system at Junshan Bridge

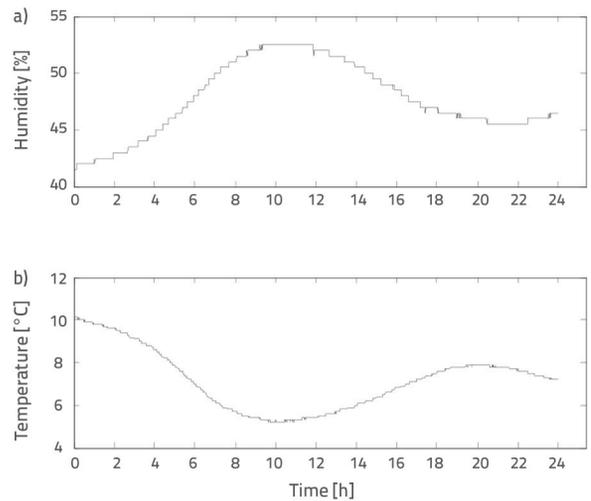
Figure 11. The curves of humidity and temperature (a) humidity and (b) temperature

As shown in Figure 11, the humidity in girder varies between 4.15 % and 52.5 % in one day, while the temperature changes between 5.2 °C and 10.1 °C. The max variation of humidity is 9 %, whereas that of temperature is 4.9 °C. The humidity declines with an increase of temperature, and vice versa. By monitoring humidity, the SHMS can remind the bridge manager to take rational maintenance measures, such as to open the dehumidifier to alleviate the corrosion risk at the steel box girder, when humidity is very high.

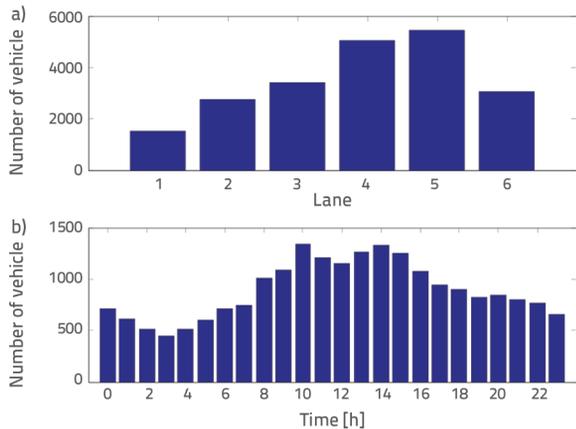
Figure 13. a) vehicle distribution per each lane; b) vehicle distribution in 24 hours

As can be seen in Figure 13, a total of 21279 vehicles cross the bridge in one day, with most vehicles, as many as 5440, pass through lane 5 and the lowest number of vehicles use lane 1. Figure 14 shows that the mean weight of the vehicles is the greatest in lane 3. The daily traffic on the bridge is busy, especially from 8am to 4pm. Because the bridge is located on a highway, the average speed of vehicles in every lane varies between 80 km/h and 100 km/h, the highest speed reaching 95.9 km/h in lane 1.

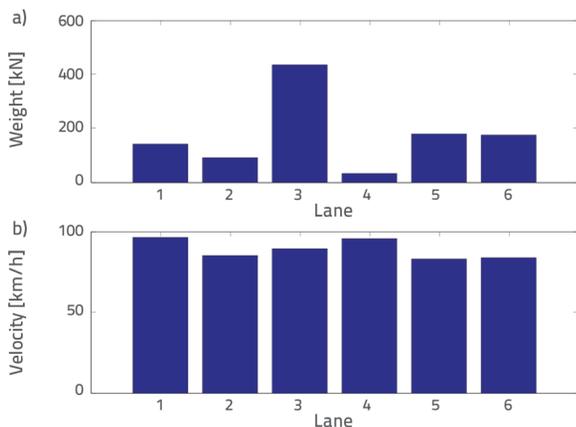
Figure 14. a) mean weight distribution in every lane; b) average speed distribution in every lane

6 from upstream to downstream. Figure 13 shows vehicle distribution result per lane and time. The mean weight and speed of vehicles in all lanes are shown in Figure 14.

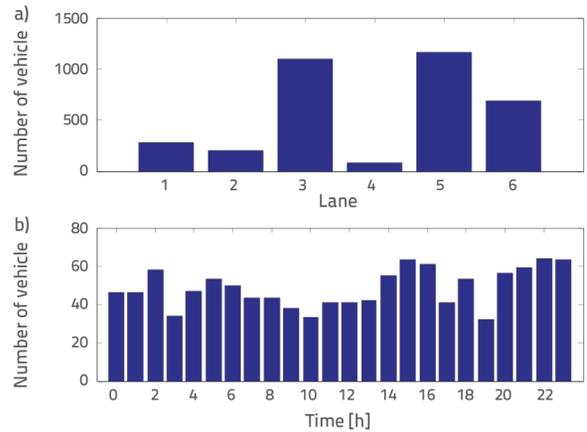
Figure 15. a) overloaded vehicles beyond 300kN in every lane; b) overloaded vehicles in lane 5 at every hour

Figure 15(a) shows that the number of overloaded vehicles in lane 5 and lane 3 exceeds the corresponding number in other lanes, with the maximum of 1162 in lane 5. Therefore, more attention should be paid to the maintenance of the steel box beam near lanes 5 and 3. Figure 15(b) indicates that the number of overloaded vehicles crossing lane 5 is dispersed and that there is no clear rush hour.

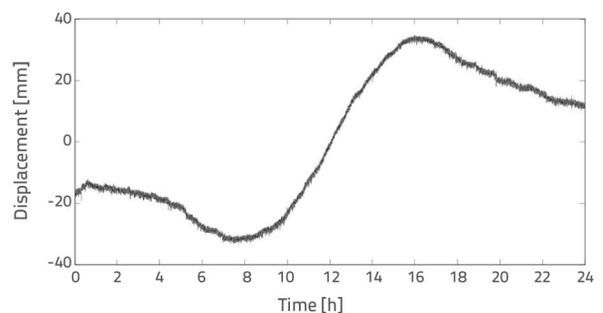
Figure 16. Curve of bearing displacement at Jinkou side

To monitor the bearing displacement, 2 Magnetostrictive displacement sensors are installed at the expansion joint on both sides of Jinkou and Junshan, respectively. The displacement data on 7 March 2015 were collected with the sampling frequency of 1 Hz, and the displacement for bearing is defined as positive when it points away from mid-span of the main span. Figure 16 shows the displacement curve of the bearing at Jinkou side marked in Figure 7 by a circle, and Figure 17 shows the regression analysis result between the temperature of the main girder and the displacement of this bearing.

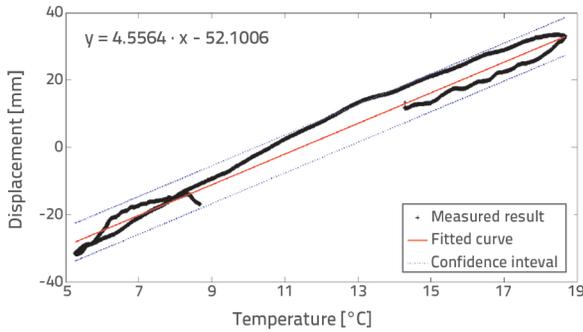
Figure 17. Regression curve between displacement of bearing and temperature of beam

The regression result indicates that there is a good linear relation between the beam temperature and displacement of bearings at both sides. The corresponding correlation coefficients at Jinkou side and Junshan side are 0.9918 and 0.9928, respectively. Based on the regression equation shown in figures 17 and 19, it can be concluded that when the temperature rises by 1 °C, the displacement of two bearings in both sides will increase by about 4.6 mm and 6.7 mm, respectively, and the sum of the displacement of two bearings is 11.3 mm, which is in good agreement with the

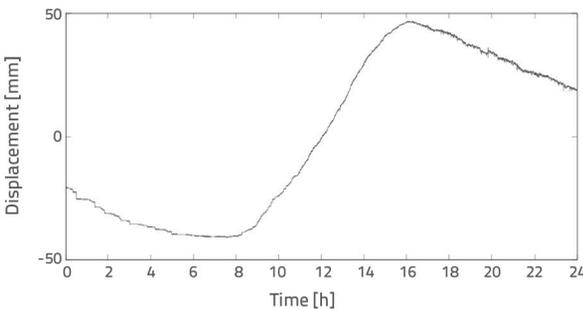
Figure 18. Curve of bearing displacement at Junshan side

The blue dashed line is 95 % confidence interval of the regression result. The similar analysis results of bearing approaching Junshan side, marked in Figure 7 by a block, are shown in figures 18 and 19, respectively.

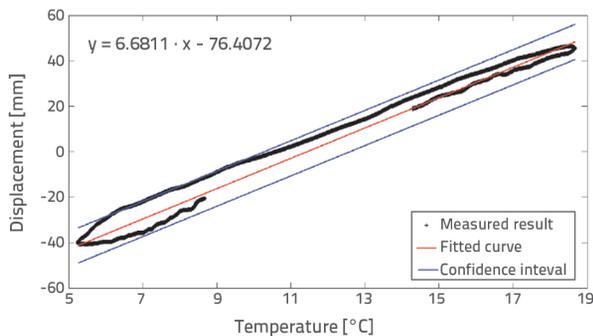
Figure 19. Regression curve between displacement of bearing and temperature of beam

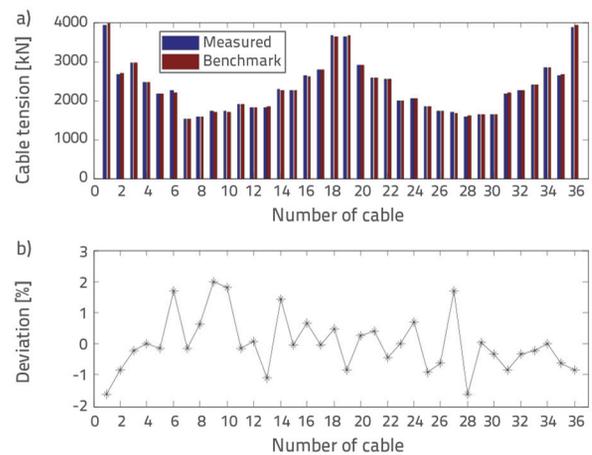
Figure 20. a) Cable tension at 2:00 am; b) Deviation between measured cable tension and benchmark results

A total of 36 accelerometers are installed on the 36 cable-stays, which are consecutively numbered as 1, 2, 3,...36 from the side of Jinkou to Junshan, and the sample frequency is 20 Hz. The power spectrum method is used to identify the cable tension at every hour. Because the cable tension changes with load and environmental factors, the data measured at 2:00 a.m. are analysed. At that time, the structural temperature field is uniform. For comparing the cable tension, the result of periodical test conducted in January 2006 is taken as the benchmark value. Figure 20 shows the cable tension identified on March 5 2015 and the deviation between the monitoring and benchmark results. As shown in Figure 20, the deviation of cable tension is less than 3 %, which indicates that the operational status of the cable-stays is normal.

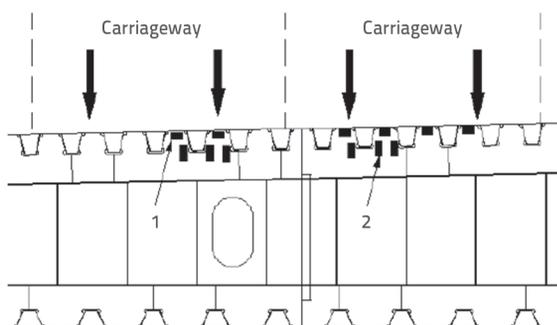
Figure 21. Layout of measuring points

Based on the measured stress data, a hot spot stress method is applied to evaluate fatigue of the steel box girder at the Junshan bridge. Considering the stress characteristics of the steel box girder, two dangerous regions are mainly evaluated: the welded joint between deck and U-rib, and the welded joint between the diaphragm and lower edge of the U-rib. Six measured points were selected for both joints, and were numbered consecutively from the left to the right, like 2-1, 2-2,..., 2-6. Figure 21 shows the layout of the measured points.

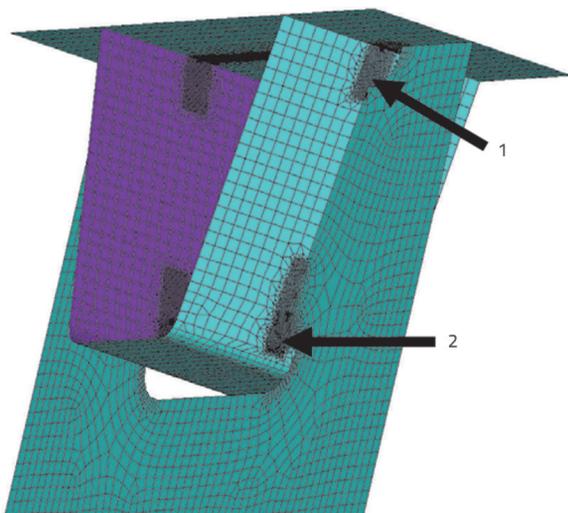
Figure 22. Local finite element model

Firstly, a FEM model of the steel box girder segment is developed to analyse the stress concentration factor (SCF). The local model is shown in Figure 22, and the calculated SCFs of two types of welded joints are 1.55 and 1.49, respectively.

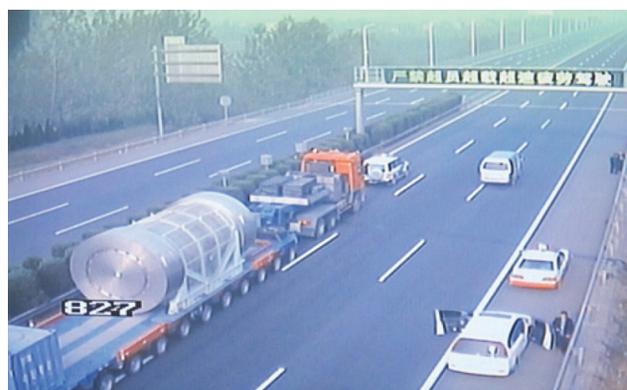
Figure 23. Photo of truck ready to cross the bridge

Two heavy trucks weighing 178 tons moved across the bridge from Jinkou side to Junshan side on 2 November 2011. The trucks were semi-trailers with multiple axles. One had 15 axles and the other had 16 axles. For the safety of the bridge, the traffic was temporarily closed from 08:32:00 to 09:14:24, and the trucks crossed the bridge at the speed of 10km/h. The first truck arrived at the expansion joint at Jinkou side at 08:43:39 and left the expansion joint at Junshan side at 08:49:32, and the time of the arrival and leaving of the second truck was 09:03:53 and 09:10:01, respectively. The weather was fine with the temperature of 18.7 °C and the breeze of 2.6 m/s. The first truck readying to cross the bridge is shown in Figure 23.

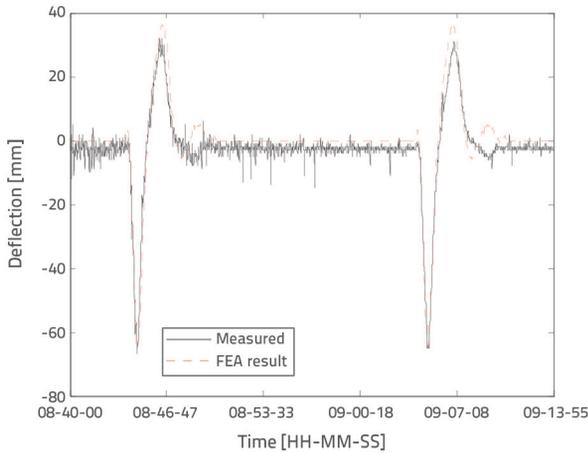
Figure 24. Deflection curve at the middle of the Jinkou side span

As shown in figures 24 and 25, the structural response was precisely monitored by SHMS when two trucks were crossing the bridge, and the measured result agrees with that of the FEA result. The maximum deflection of the beam at the side and main spans was 67 mm and 136 mm, respectively. The residual deformation after trucks passed the bridge was very small, which indicates that the deformation is elastic and that the force characteristics of the structure did not change.

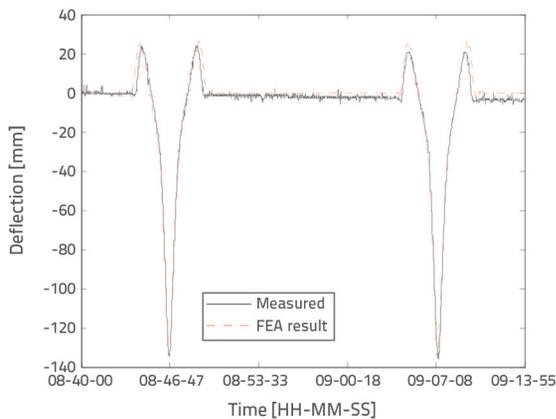
Figure 25. Deflection curve at the middle of the main span (downstream)

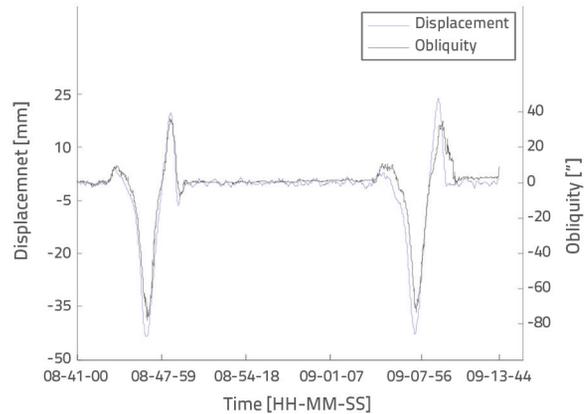
Figure 26. Monitoring longitudinal displacement and inclination of Junshan tower

The result indicates that the variation of longitudinal displacement is in accordance with that of the inclination, which corroborates good cross-calibration from different types of sensors. The maximum displacement and inclination is 43.8 mm and 78.0°, respectively, and the minimum is 23.9 mm and 36.5°, respectively.

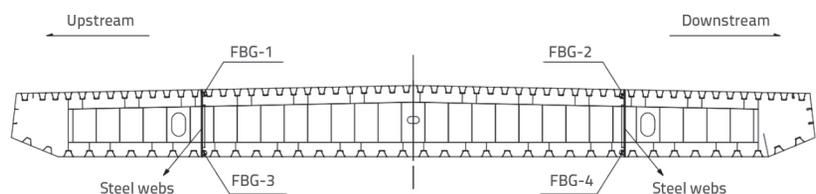
Figure 27. Layout of stress measuring points on steel webs

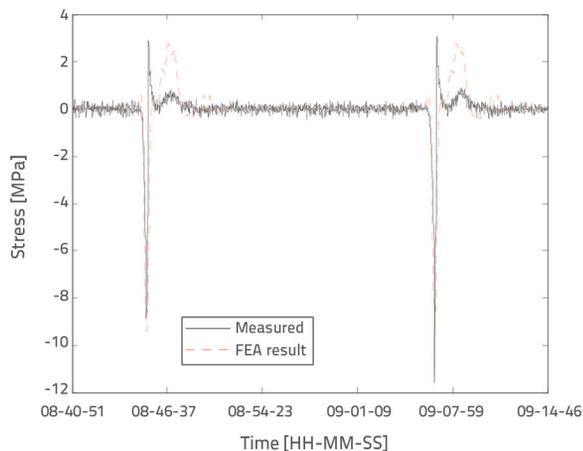
Figure 28. Stress curve of upper measuring point at middle of Jinkou side span (downstream webs)

In Figure 28, some discrepancy can be noted between the measured stress and the FEA result, maybe because the sensor was not precisely installed on the girder, i.e. at the designed angle and position, so that, in a certain range, the measured time series may not agree well with theoretical values.

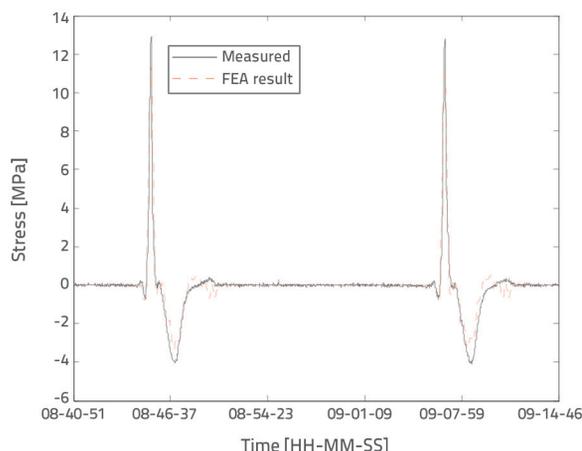
Figure 29. Stress curve of lower measuring point at middle of Jinkou side span (downstream webs)

Figures 29 to 31 show that measured results are consistent with FEA results. Under the load of trucks, the top of the steel webs is mainly under compression, and the bottom of the webs is under tension. The maximum and minimum stress in the side span is 12.9 MPa and -11.6 MPa, and the result in the main span is 16.0 MPa and -10.9 MPa. Therefore, it can be concluded that stresses at steel webs in the main span are larger than those in the side span.

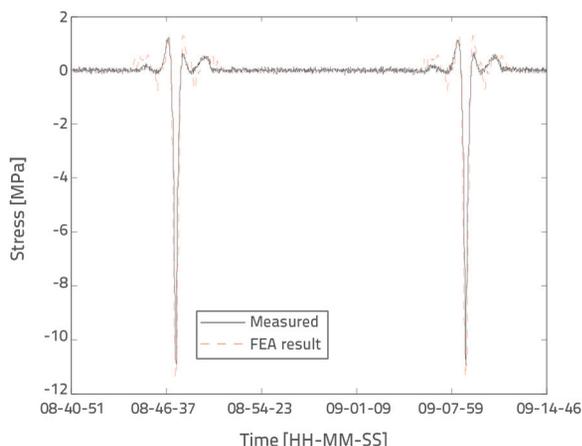
Figure 30. Stress curve of upper measuring point at middle of main span (downstream webs)

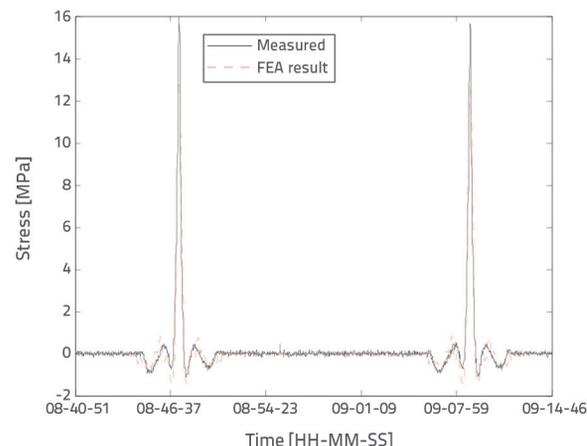
Figure 31. Stress curve of lower measuring point at middle of main span (downstream webs)
