Architectural and structural analysis of historical structures

Professional paper

One of the most notable examples of Amasya's cultural heritage is Gok Madrasah (literally: Sky or Blue Madrasah). Gok Madrasah was built in a central location in Amasya. Because of blue glazed bricks used in the structure, the structure has been named Gok Madrasah (Sky or Blue Madrasah) (Figures 1 and 2). Since there is no inscription, the precise construction date is unknown. However, according to its patrons, the madrasah was constructed by Seyfeddin Torumtay, who was a governor in Amasya during the Seljuk period.

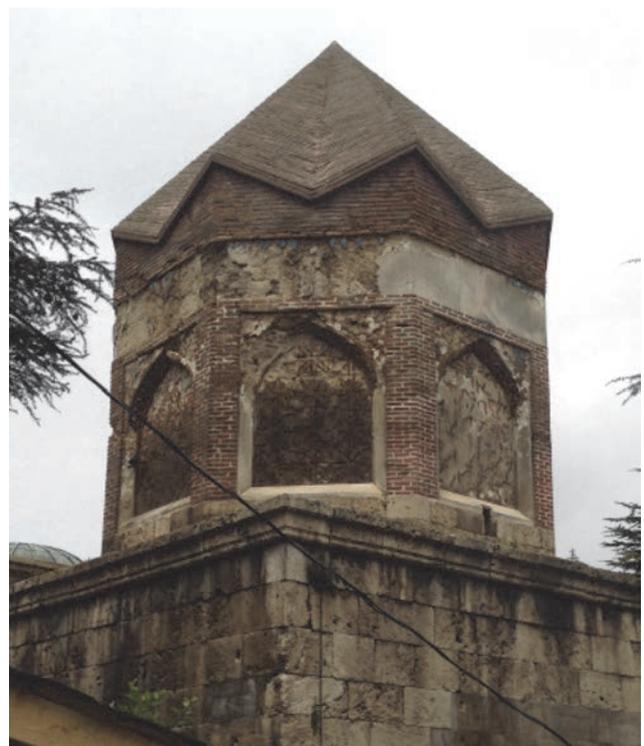
Figure 4. Octagonal pyramidal section

The binding material between the masonry units was partially eroded. The most deteriorated parts of the madrasah are on the octagonal pyramidal section. In some cases, the abrasion and degradations are noticeable on the stone units of the masonry facades. In addition, the madrasah has been subjected to natural disasters and destruction by human hands (Figure 8). Some of this damage is very dangerous because it may cause fatal and destructive cracking and fracturing. In addition, it can cause differential movement of the madrasah components. Consequently, such damage should be taken seriously and precautions should be taken to avoid or to abate its effects.

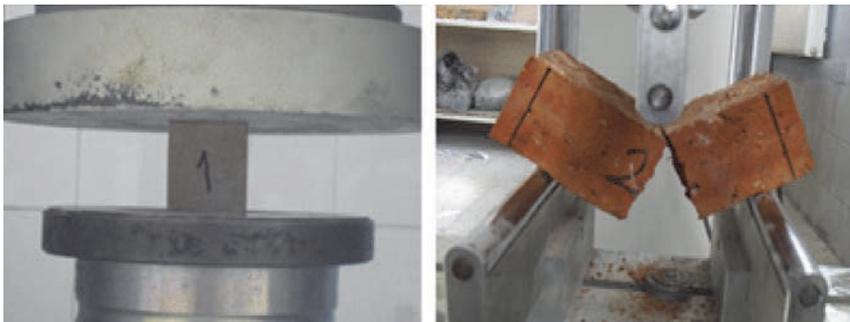
Figure 9. Mechanical testing of materials

In laboratory tests, the compressive strength values of the stones varied between 43.96 to 57.19 MPa. An average compressive strength was determined to be 50.92 MPa. The tensile strength values varied between 7.45 MPa and 7.61

MPa. An average tensile strength was 7.55 MPa. As for bricks, the compressive strength values ranged from 15.85 to 19.32 MPa, and an average compressive strength was 17.49 MPa. The tensile strength varied between 2.64 MPa and 2.82 MPa, and an average tensile strength was 2.69 MPa [9]. Mechanical properties used in all numerical analyses are summarized in Table 1.

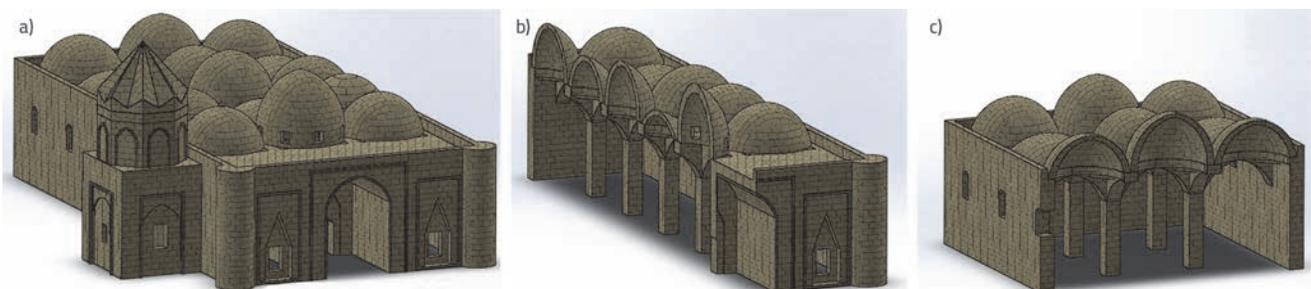
Figure 10. a) Three dimensions model; b) Longitudinal section; c) Transverse section of the structure

The most critical part of the structural analysis for Gok Madrasah is to develop a numerical model with finite element members and nodes. Ideally, the numerical model should represent the structure that is being studied. In this study, a three-dimensional finite element model was developed based on the geometrical constraints and structural condition of the structure (Figure 10).

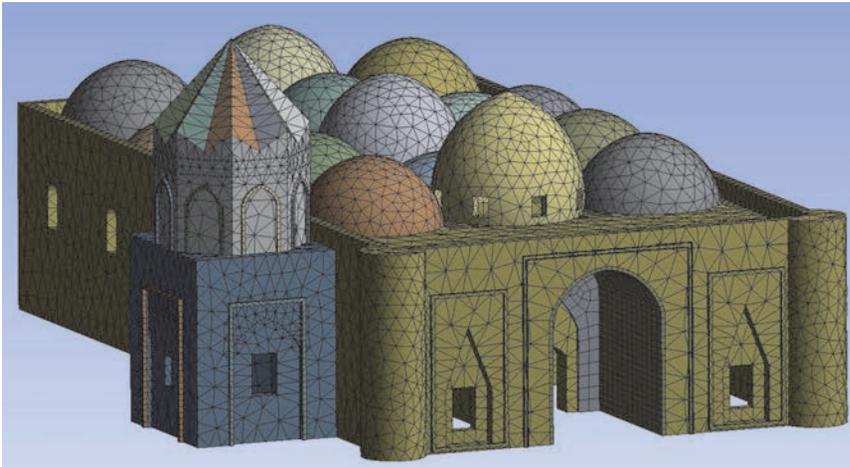
Figure 11. Finite element model of the structure

The finite element model of Gok Madrasah was created using the finite element software ANSYS Workbench [18]. In the numerical model, the structure was constituted with 135311 nodes and 55373 Solid186 elements, which have 20 nodes and three degrees of freedom per node. The numerical model for Gok Madrasah is shown in Figure 11. The scope of this paper deals mainly with solids and structures of elastic materials.

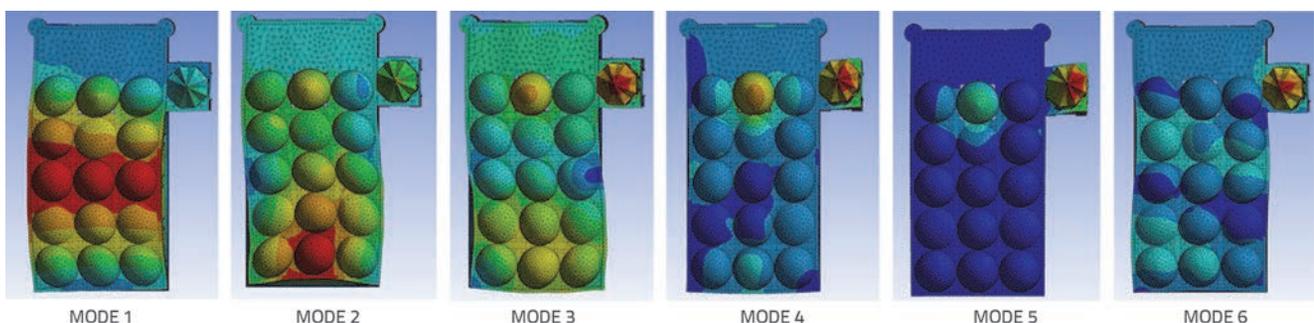
Figure 15. Mode shapes and directions of the first six modes

Modal analysis is used to estimate and to analyse the dynamic response of structures. The aim of modal analysis is to define the frequencies and mode shapes. In this study, the modal analysis was primarily used for the dynamic behaviour and it was considered for the first six modes. The frequencies, periods, and participation ratios are presented in Table 2, and the first mode shapes and directions are presented in Figure 15.

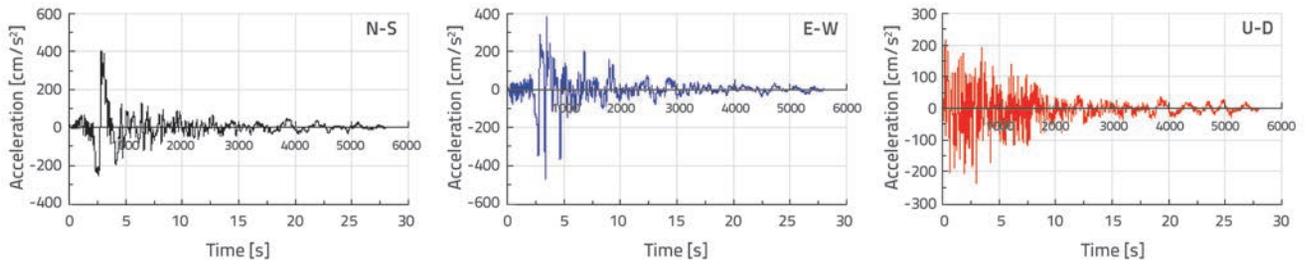
Figure 16. Ground motion record of Erzincan earthquake: North–South (left), East–West (middle) and Up–Down (right), [20]

In the time history analysis, the Rayleigh damping with 5% damping ratio was used. The dynamic time history analysis was conducted using a ground motion record from the March 13, 1992 Erzincan earthquake, which has been one of the strongest earthquakes in Turkey to date, with a magnitude of 6.8. The acceleration records of the Erzincan earthquake at central station were considered. The raw PGA Values are 404.97, 470.91 and 238.55 cm/s^2 in the North – South, East – West and Up – Down, respectively [20], and the structure was only

subjected to the north-south direction, which is the biggest component (Figure 16). Moreover, Rayleigh damping with five percent damping ratio is used in the time history analysis.
