# Time-dependant stability of slopes excavated in marl

Prof. **Predrag Mišćević**, PhD. CE  
University of Split  
Faculty of Civil Engineering, Arch. and Geodesy  
Department of Geotechnical Engineering  
[predrag.miscevic@gradst.hr](mailto:predrag.miscevic@gradst.hr)

**Goran Vlastelica**, B.Sc. CE  
University of Split  
Faculty of Civil Engineering, Arch. and Geodesy  
Department of Geotechnical Engineering  
[goran.vlastelica@gradst.hr](mailto:goran.vlastelica@gradst.hr)

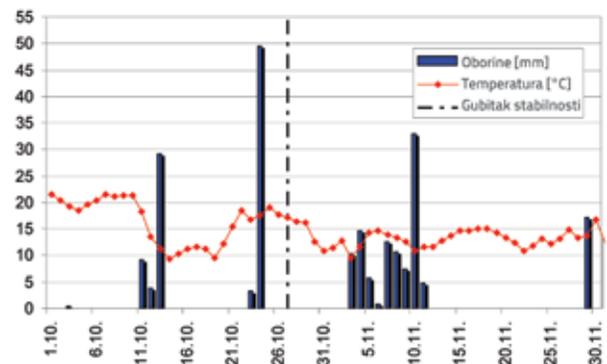
The physical weathering is manifested in the breakup of material due to development of cracks, and in surface dissolution in contact with water. By excavation in thin formations, bedding joints are exposed to external influences. These are the weakened surfaces in which the detachment of fragments is most likely to occur, and are at the same time most susceptible to external influences, i.e. to the action of water which penetrates into the rock. This sudden absorption of water results in development of pressure in rock joints which leads to slaking, and hence to the extension (deepening) of joints. In addition, release of stress provoked by removal of material during excavation (relaxation) causes development of new joints (listric joints). The development of new joints speeds up physical weathering and enables deeper penetration of chemical weathering effects. A significant influence of freezing on the speed of disintegration process has been analyzed in detail on some weak rock examples in Spain [7] and Turkey [9]. The above assertions are also confirmed by typical landslide behaviour at cut slopes realized in flysch, i.e. the sliding/material fall most often occurs after a period of abundant precipitation, especially if during this period temperatures at soil surface fall below freezing point. The distribution of precipitation and air temperatures in Split area in the period in which the landslide occurred during construction of the Medical School in Split is presented in Figure 5. This landslide is shown as an example in Figure 2. As the date on which the landslide actually occurred was noted, it can be observed that the landslide was preceded by significant rainfall. This example shows that water has a dominant influence on the occurrence

of such landslides. In addition to the influence of water on the weathering process (and hence on the reduction in strength), the following water related effects can also be observed: soft rocks affected by weathering process have the lowest strength in wet condition; due to weathering of the material the water penetrates the joints and the pressure builds up within such joints. For that reason, the effect of weathering was simulated in laboratory (as presented below) through drying and wetting, while the strength was measured on wet samples. In addition, the behaviour observed in nature shows that the influence of water pressure on shear strength along joints/surfaces should be taken into account in stability analyses.

Figure 5. Quantity of precipitation and air temperatures in Split area (in period of sliding occurrence during medical school construction)

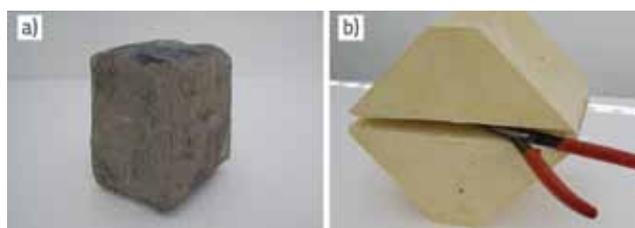
The basic problem in this analysis is that the tested sample disintegrates very rapidly during the weathering process, due to intense changes in moisture [17]. To enable this testing, the decision was made to use the testing procedure that is in fact a modification of the standard procedure for testing shear strength by means of a portable direct shear apparatus for rocks. Test samples were taken from the freshly excavated zones and sawn without water, so as to prevent disintegration prior to the testing. Samples were cut to dimensions of about 10 x 10 x 8 cm. Before installation in the testing plaster, the samples were wrapped in metallic mesh that can easily be fitted around the sample (Figure 7a). The mesh 2 mm in aperture was selected. It was determined during the testing that the testing plaster can reach the sample through this aperture and, at the same time, the aperture is small enough to prevent a significant loss of sample during simulation of the drying and wetting process. This mesh is cut immediately before the testing according the shearing surface defined in advance (Figure 7b) so as to eliminate the influence of mesh strength on test results.

Figure 7. Preparation of test samples: a) sample wrapped in mesh before it is placed into the testing plaster; b) example of mesh cutting once the sample is placed into the testing plaster

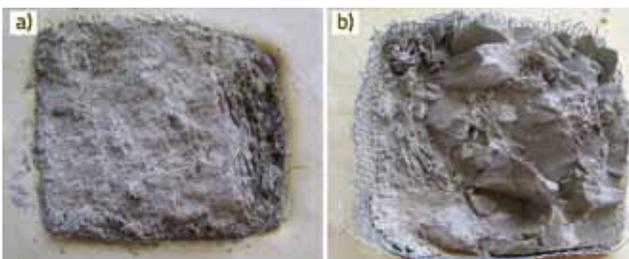
An increase in the value of angle of friction after the first drying and wetting cycles is also typical for these samples. Visual inspection of such samples, conducted after the testing, shows that the sample is divided into a number of coarse fragments, but the degradation does not reach the material in the deeper zone (Figure 8b). A part of fragment from the surface of the presented sample has detached due to shearing and separation of the pieces of sample, and a continuous failure surface can not be noticed. During shearing, the sample behaves as a well graded compacted gravel, which may be the cause of apparent increase in the angle of friction.

Figure 8. Examples of failure surfaces during weathering simulated in laboratory: a) failure surface after 4 drying-wetting cycles; b) failure surface for the sample that disintegrated into smaller fragments due to weathering action

Samples containing more than 50 % of clay minerals, as is the case in sample "B", consistently show full degradation at a relatively small number of drying-wetting cycles (2 to 4 cycles), cf. Figure 8a. The weathering effect can be seen throughout the depth of the sample. Samples that are still

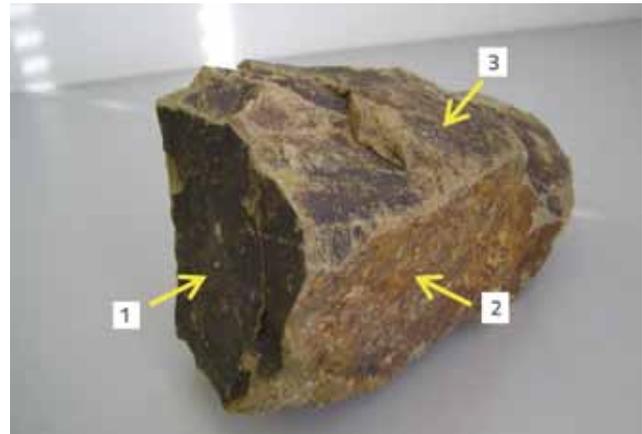
secondary joints (Figure 12), random joints or joints formed by weathering, and through basic material (marl). An example of landslide along secondary joints is shown in Figure 13 (enlarged detail from Figure 11g). The fact that the water seeps through these joints is proven by plant roots (marked in the Figure) which follow the spreading of such secondary joints.

Figure 12. Marl sample with three joint systems almost perpendicular to each other (first and third – secondary joints; second – bedding joints)

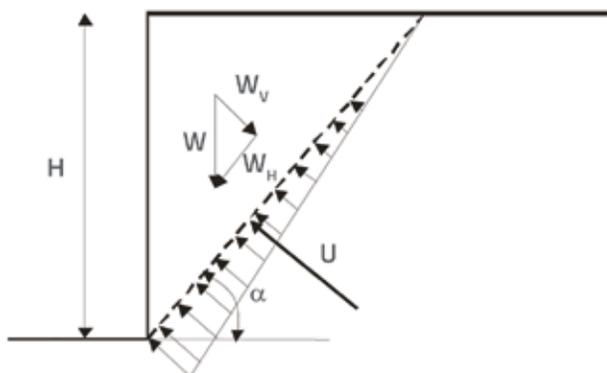
The parametric analysis of wedge sliding along the joint at an angle  $\alpha$  (cross section in Figure 14) was conducted in the scope of analysis of shear strength at which the sliding occurs. This analysis was conducted for the side cut 10m in height. The rock mass was modelled with the unit weight of  $\gamma = 23 \text{ kN/m}^3$ , and the cohesion and joint inclination toward the side cut ( $\alpha$ ) were varied for the constant angle of friction along joints  $\varphi_j = 30^\circ$ . The value of the angle of internal friction was selected based on shear strength measurements in marl, as shown in Tables 2, 3 and 4, and for the weathered and non-weathered samples. The goal was to define the value  $c_j$  for which the limit state ( $F_s = 1$ ) is obtained at different joint dip values ( $\alpha$ ). The influence of water pressure on joints is

analyzed under assumption that the bottom end of the joint was still non-weathered immediately prior to fracturing i.e., that water could not have escaped toward the bottom end of the joint. Thus the hydrostatic pressure was modelled along the joints (example from Figure 10). The following expression was derived from these conditions:

Figure 14. Model of wedge sliding along the joint, as used in parametric analysis

Parametric analysis results are presented in Table 5. If cohesion values obtained from the above analysis are considered, it can be concluded that they roughly correspond to the cohesion value measured at degraded samples treated by laboratory weathering (Tables 3 and 4). The end product of weathering is the residual material in form of marly clay, and the shear strength of fully degraded material should correspond to the strength of marly clay. However, the weathering level is not necessarily the same along the entire length of the joint, or along the material depth. For that reason, the shear strength at which the failure and sliding occur can only be taken as an average value along the failure surface.
