Assessment of structural performance of historical Ishan church

Professional paper

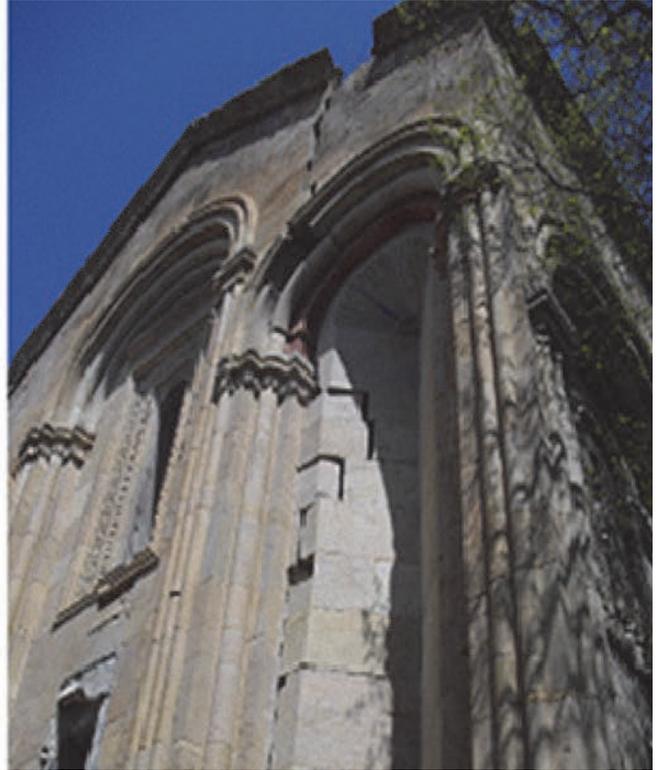
Furthermore, several different-size mature cracks were detected on the upper parts of walls of the structures, and in different zones. A notable example is one significant crack on the west façade that runs along the height of the wall (Figure 5). Therefore, this crack is the greatest threat to the structure's safety since it significantly separates the two walls.

This significant wall that connects the west wall and the south wall stretches from the upper part of the wall to the foundation. On-site measurements have revealed that the crack width varies between 2 and 15 cm, and the crack caused a gap between the south wall and the west wall. Figures presented in Takaichvili's studies, conducted in 1952 and 1960 [1, 2], show that the crack on the west side existed already in 1917, and that the width of that crack is similar to the width of the present-day crack (Figure 6). Nevertheless, the pictures also show that the demolished vault did not exist in 1917 and that these sections were covered with a wooden roof during the period when the structure served as a mosque. It can therefore be stated that the west façade cracks and vault deformations occurred at least 100 years ago and that these deformations have not changed to this date.

rooms to the apse are completely demolished, as can be seen in Figure 7. Some small cracks can be seen on the east façade of the structure, mostly in upper parts. The repair and reinforcement studies must concentrate on the entire supporting system, and on the deep crack on the west side. Moreover, drainage excavations prove that the foundation soil is in a good condition, and that there is no significant damage to the structure's foundations.

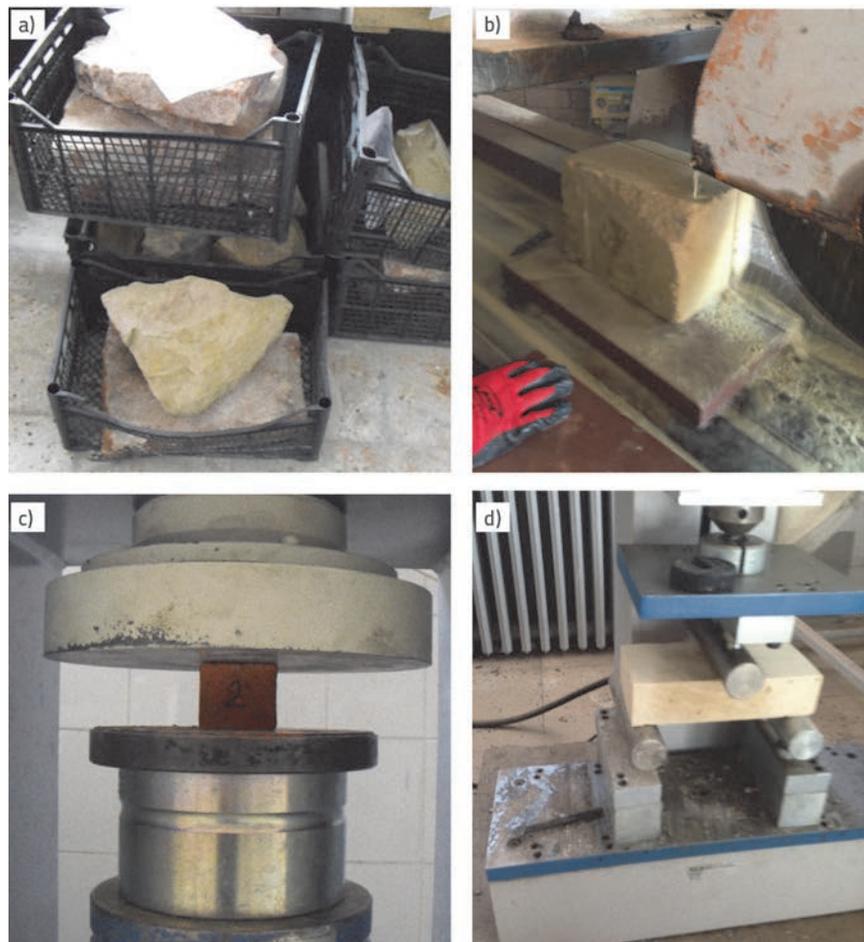
Figure 8. Preparation and testing of specimens: a) collected masonry units; b) preparation of specimens; c) compression test; d) three-point bending test

The compressive strength values of stone specimens varied between 39.98 MPa and 42.25 MPa. According to compression tests, an average compressive strength of stone specimens amounted to 41.20 MPa. The tensile strength generally varied between 2.79 MPa and 3.01 MPa. The average tensile strength value was found to be 2.91 MPa. With regard to handmade bricks, compressive strength values ranged from 19.15 MPa to 21.02 MPa, and the average compressive strength amounted to 20.23 MPa. The tensile strength varied between 1.32 MPa and 1.51 MPa, and the average tensile strength obtained was 1.42 MPa. According to the Turkish Earthquake Code 2007 [7], the modulus of elasticity (Ed) for masonry units can be calculated from $E_d = 200f_d$, where f_d is an average compressive strength of masonry units. The equivalent density values for construction materials were determined through test results for ten specimens. Mechanical properties used in all numerical analyses are summarized in Table 5.

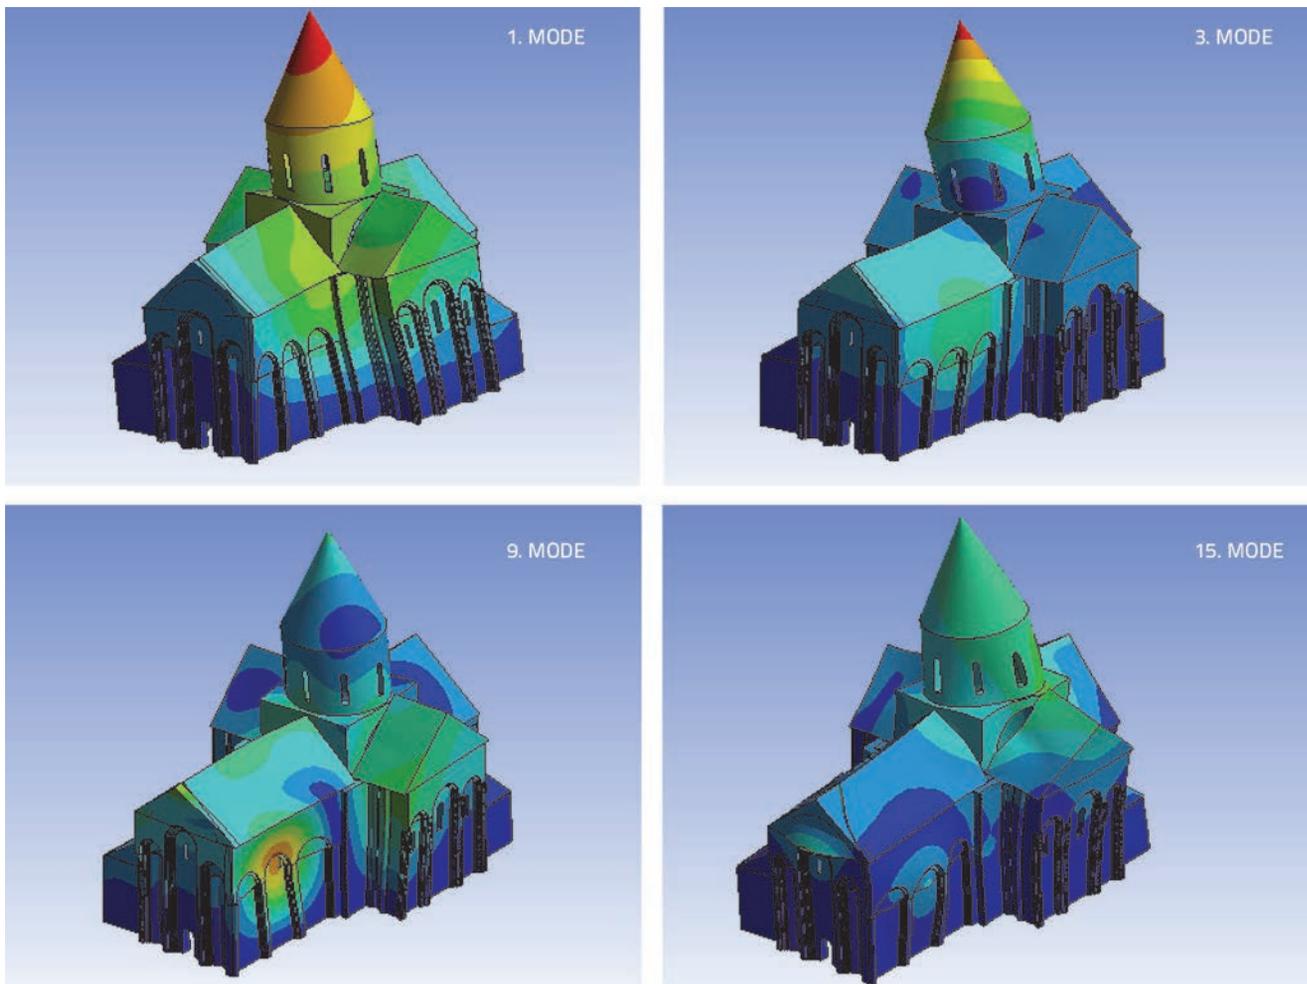
Figure 13. Some mode shapes

five modes that have higher contributions to the effective mass participation ratios. Therefore, in modal analyses, the solution is made for 30 modes, while five of the modes that are considered to be risky deserve careful attention (Table 6).

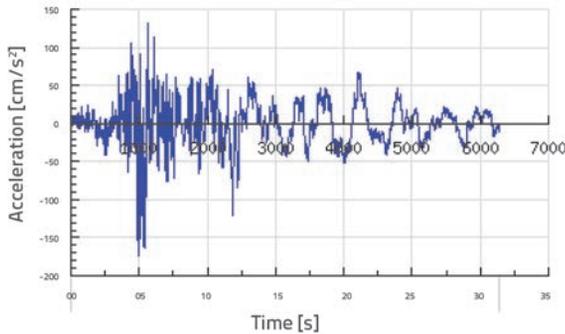
Figure 16. Erzurum - Kars earthquake East-West acceleration component [14]

The Erzurum-Kars Earthquake, which occurred on 30 October 1983 in Erzurum near the town of Artvin, is also considered in this study. The corresponding dynamic analyses were conducted using the time-history analysis method. In the analyses, the Erzurum-Kars Earthquake acceleration records were acquired from Horasan Station, and the East-West (E-W) acceleration component [14] from powerful territory movements was taken into consideration (Figure 16).
